Culvert Repair Programmatic Agreement 2020 Annual Report

**Oregon Department of Fish and Wildlife | Oregon Department of Transportation
January 2022**

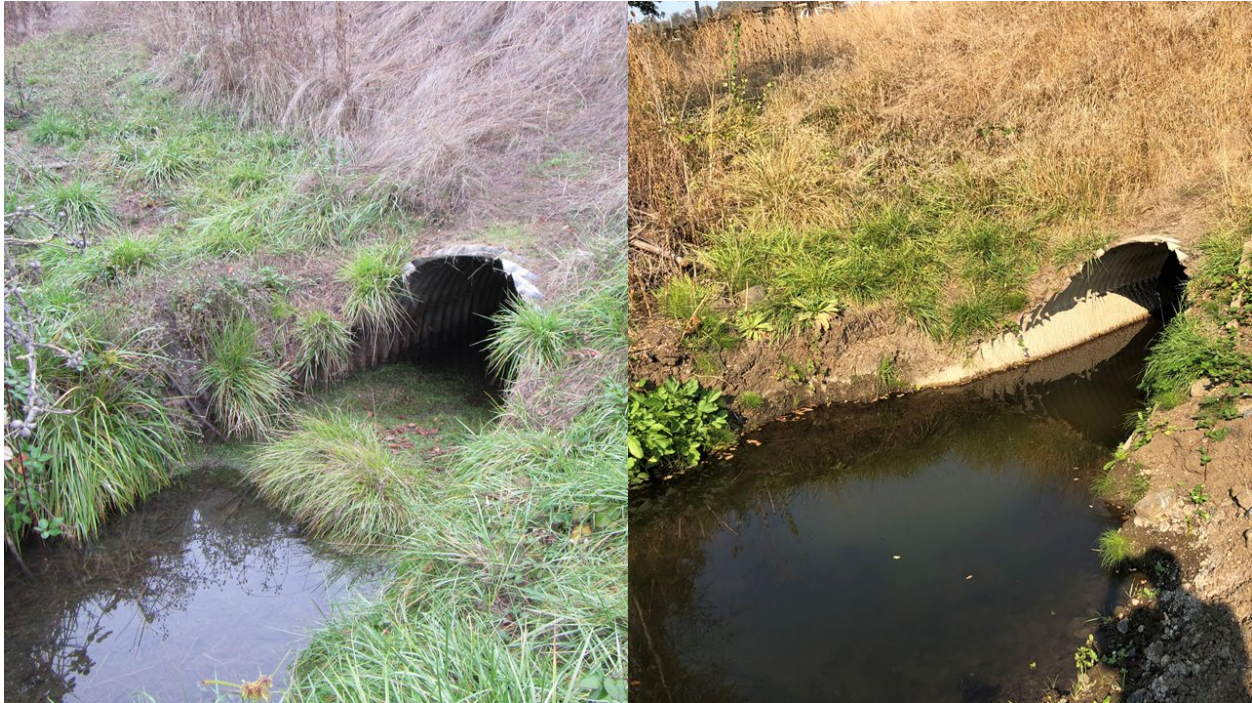
Figure 5: Unnamed Tributary to Roberts Creek Before and After

The culvert's structural condition was deteriorating due to barrel and invert damage, and in need of repair. The active channel width at the site was estimated at 12 feet. Hydraulic calculations determined that during 5% daily exceedance flows (high fish passage design flow) the culvert had velocities of 4.90 fps, and depth at the outlet was 2-5/8 inches at the 95% daily exceedance flows (low fish passage design flow). This compares to an ODFW fish passage design criteria maximum velocity of 2 fps at high fish passage design flow, and a minimum water depth of 6 inches at low fish passage design flow.

The culvert was repaired with a 6-inch paved invert treatment and staggered fish baffles were placed every 15 feet to decrease velocity and create hydraulic variation. Hydraulic calculations estimated a post-treatment high fish passage design flow velocity of 4.01 fps, and a low fish passage design depth of 3 inches. The reduction in velocity and increase in depth improved access to approximately 0.7 miles of potential habitat for cutthroat trout.

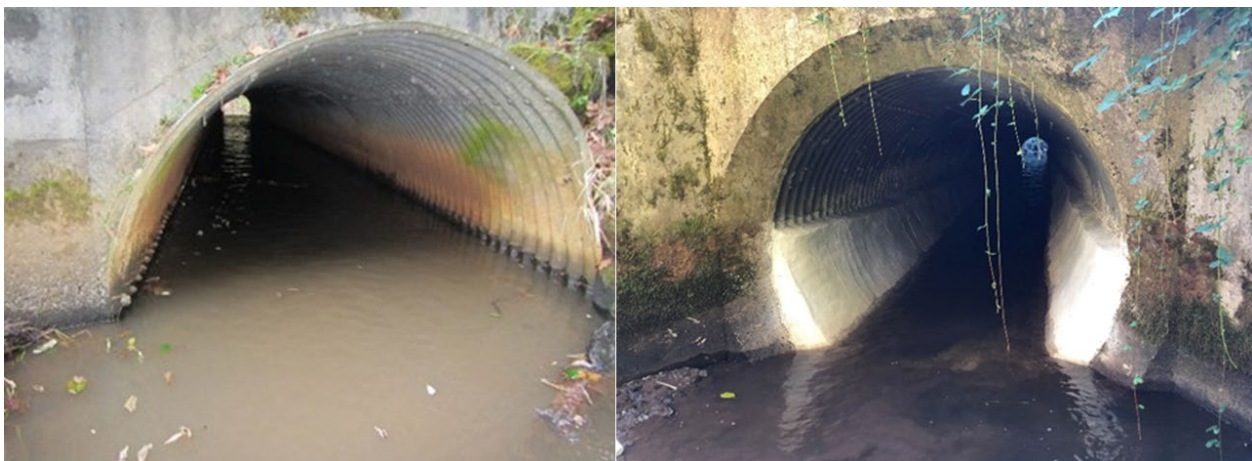
Figure 6: Pass Creek Culvert Repair Before and After

The culvert's structural condition was deteriorating due to distortion, barrel damage, and invert damage, and in need of repair. The active channel width at the site was estimated at 15 feet. The culvert was determined to have shallow depths during periods of low flow, creating a partial fish passage barrier.

The culvert was repaired with a 6-inch paved invert and staggered fish blocks were placed every 5 feet to increase flow depths and create hydraulic shadow. The increased water depth and addition of hydraulic shadow improved access to approximately 1.96 miles of potential habitat for cutthroat trout and steelhead/rainbow trout.

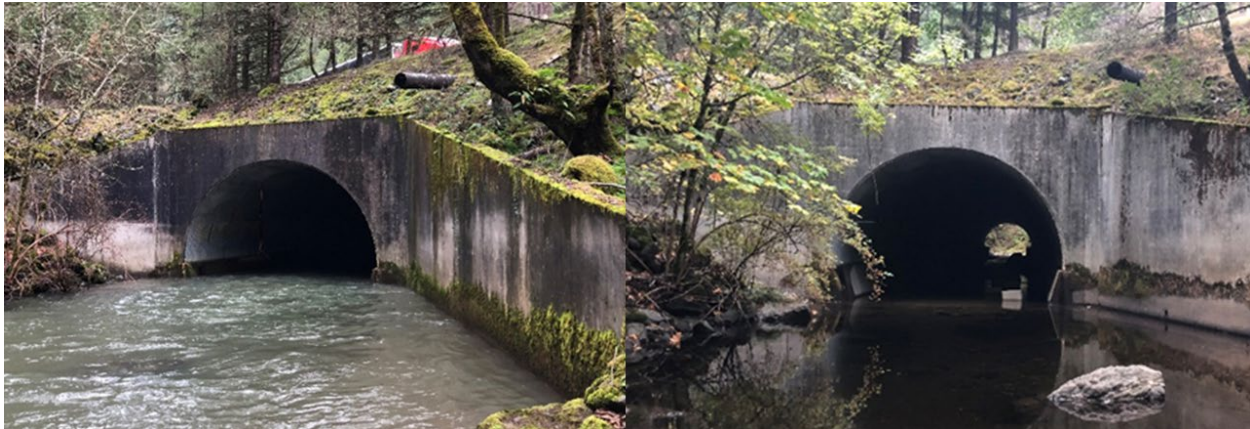
Figure 7: Canyon Creek Culvert Repair Before and After

The culvert's paved bottom was severely deteriorated and had several voids, causing water to flow under the culvert. The active channel width at the site was estimated at 25 feet. Pre and post project hydraulic calculations of velocity and depth were not determined for this culvert. Moderate and high velocities were observed during winter months. To improve fish passage, the project proposed to reduce velocity during moderate and high flows and retain a V-shaped notch in the bottom of the culvert for fish movement during low summer flows.

Concrete repairs were made to the culvert invert and staggered fish blocks were placed every 10 feet on river left inside the culvert to decrease velocity and maintain the existing low flow notch. The decreased velocity and low flow channel improved access to approximately 13.14 miles of habitat for cutthroat trout, federally listed coho salmon, and steelhead/rainbow trout.

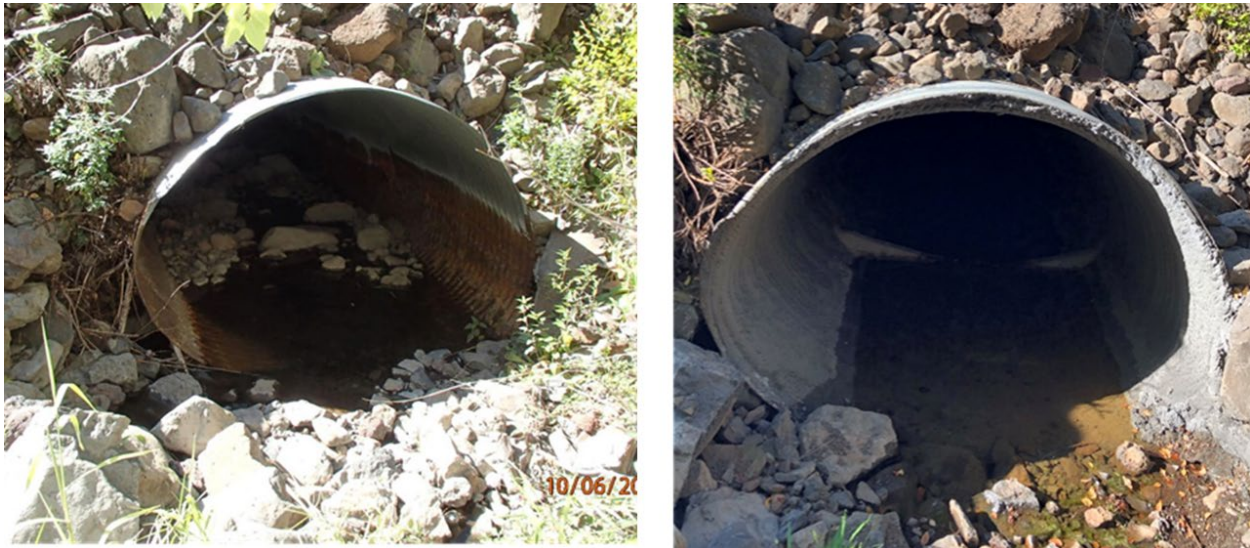
Figure 8: Unnamed Tributary to Willowa River Culvert Repair Before and After

The culvert was partially filled with larger rock material and its invert was rusted through in multiple spots, resulting in the culvert being impassable during low flow conditions. Hydraulic calculations determined that high fish passage design flow conditions at the culvert had velocities of 4.38 fps and had less than two inches of depth during low fish passage design flow levels.

The rock and gravel material were removed from the culvert and a sprayed on concrete liner was used to repair the invert. Eight-inch-high weirs placed every 12 feet were installed to decrease high flow velocity and increase low flow depths. Hydraulic calculations estimated a post-treatment design high flow velocity of 3.12 fps and design low flow depth exceeding 8

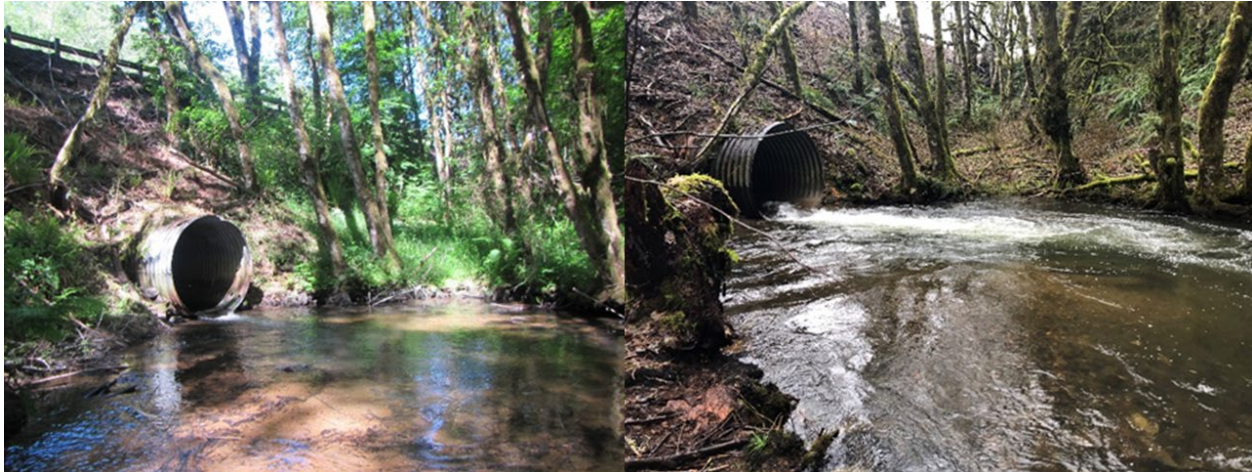
Figure 9: Rock Creek Culvert Repair Before and After

The culvert was in critical condition, with large voids from a rusted invert leading to the piping of water under the culvert. Hydraulic calculations determined that during periods of high fish passage design flows, the culvert had velocities up to 5.77 fps. During periods of low fish passage design flow, models estimated less than three inches of water depth in the culvert. Also, the culvert outlet was perched at low flow, and a trash rack not meeting fish passage design criteria was present upstream of the culvert.

The culvert was repaired with a 6-inch paved invert and six baffles were placed every 25 feet to reduce velocities inside the culvert. An existing riffle was treated with additional boulders at the tail of the outlet pool to create additional roughness and reduce the perch during low flow. Hydraulic calculations estimated a post-treatment velocity of 1.65 fps during high fish passage design flows, and depths of over 2 ½ feet during low fish passage design flow. The decreased velocity, increased depth, and reduced perch improved access to approximately 6.48 miles of habitat for cutthroat trout, federally listed coho salmon, steelhead/rainbow trout, and lamprey.
