# Culvert Repair Programmatic Agreement 2018 Annual Report

Oregon Department of Fish and Wildlife | Oregon Department of Transportation  
January 2021

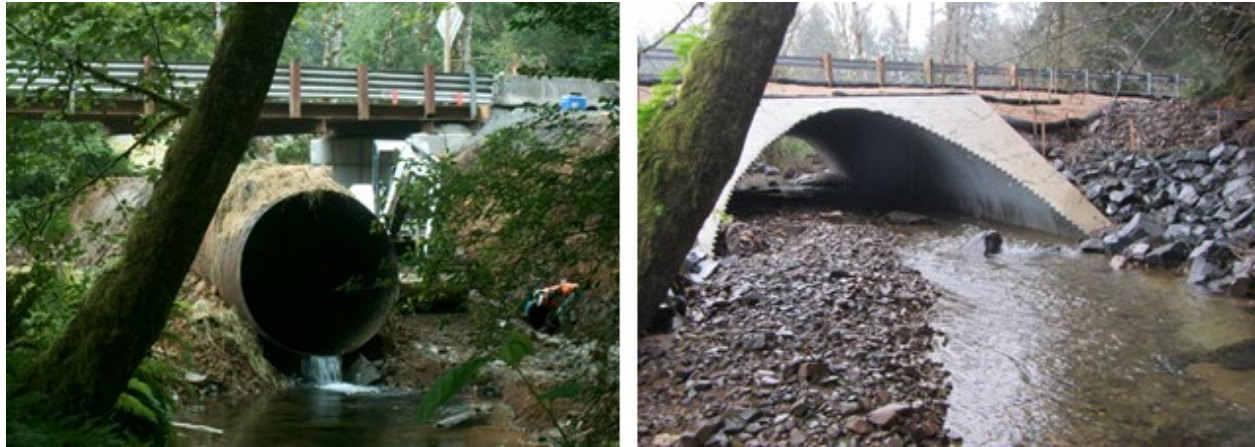
Figure 2: Joe Creek Culvert Replacement Project, Before and After

The Joe Creek culvert replacement project, Figure 2, completed by the ODOT Fish Passage Program, is one example of ODOT's commitment to improving fish passage and supporting the Oregon Plan for Salmon and Watersheds. The project replaced an undersized 8-foot diameter corrugated metal culvert with a 20-foot wide arch culvert. The Joe Creek fish passage project opened two miles of high-quality spawning and rearing habitat for coho and Chinook salmon and steelhead at the cost of \$1.6 million. The original culvert, installed in 1950, was undersized for the stream channel. This construction blocked anadromous fish from accessing the upstream habitat for more than half a century.

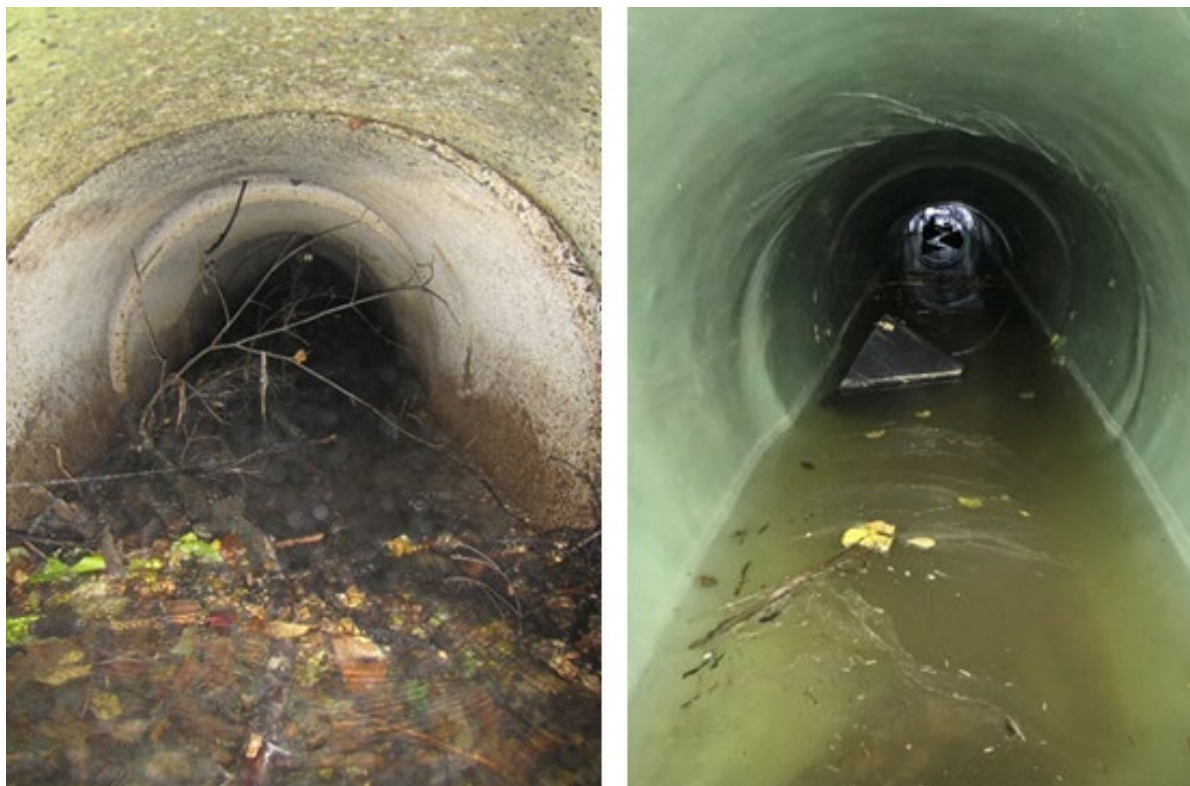
Figure 4: Unnamed Tributary to Pheasant Creek Culvert Repair Before and After

This 80-foot long culvert is a 36" diameter corrugated metal pipe (CMP), passing a stream with an estimated active channel width of 14 feet. The culvert's structural condition was considered poor, due to severe settlement and open joint issues. If left untreated, these issues could allow water to escape the culvert and erode the soil arch under the roadway, ultimately leaving the highway unsupported and unsafe. Hydraulic calculations show flow conditions at the culvert had velocities of 2.44 fps and flow depths as low as 1.5 inches (flows ranging between 5 percent and 95 percent of the daily exceedance stream discharge). This flow exceeded the ODFW fish passage criteria of 2 fps. Species using the habitat upstream of the culvert include cutthroat trout and possibly pacific lamprey. The culvert was a partial velocity barrier to these species, potentially blocking or delaying access to approximately 0.2 miles of habitat.

The degraded culvert was repaired with a cast-in-place pipe liner that sealed the joints and alleviated the settlement issues, keeping the water flowing inside the culvert. Fish passage was

improved with the addition of staggered one-piece polymer baffles with rounded edges. These baffles were placed to decrease the velocities within the culvert and offer ample hydraulic variation for NMF. The rounded edges of the baffles were an important fish passage detail due to the possibility of adult Pacific lamprey in the system. Post-treatment conditions were estimated to have velocities of 1.03 fps and flow depths of 6.7 inches, thus improving access to the approximate 0.2 miles of upstream habitat.

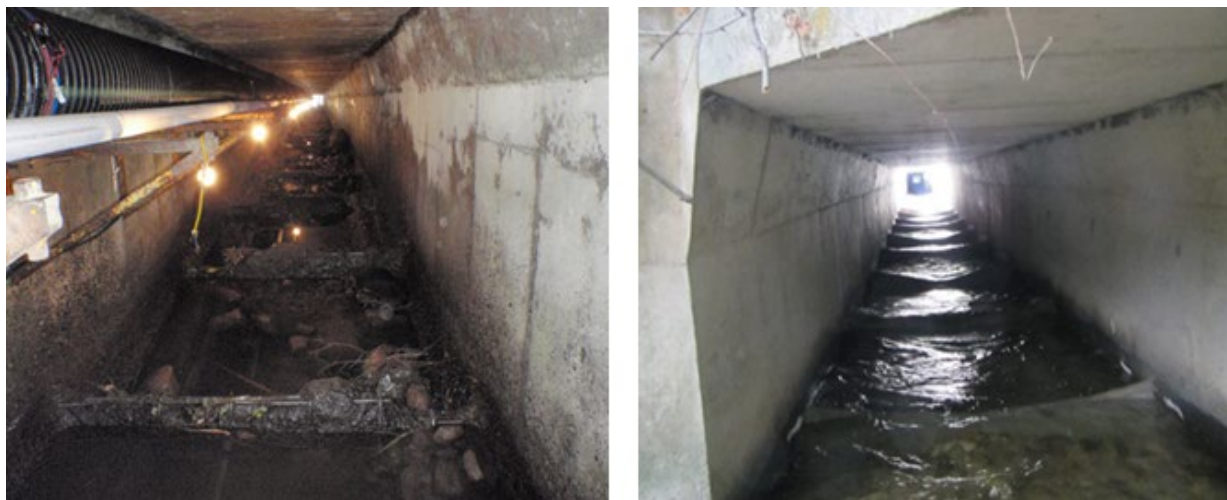
Figure 5: Neil Creek Culvert Repair Before and After

This concrete box culvert is 435 feet long, eight feet wide, and eight feet tall. The culvert's condition prior to repair was poor due to invert degradation. Invert degradation allows water to saturate the soil surrounding the culvert. It also erodes away the soil beneath the culvert and can lead to settling. If left untreated, these issues can lead to the roadway becoming unsupported and unsafe. The hydraulic conditions within the culvert presented numerous issues, including passage barriers of increased jump heights over the old concrete weirs and high velocities during high flow.

The culvert invert and concrete weirs were repaired, amending the invert degradation issue. The repair of the concrete weirs improved fish passage. These lowered the velocity in the culvert and allowed for variation of hydraulic conditions through the culvert to improve NMF passage conditions to the potential 8.9 miles of habitat upstream.

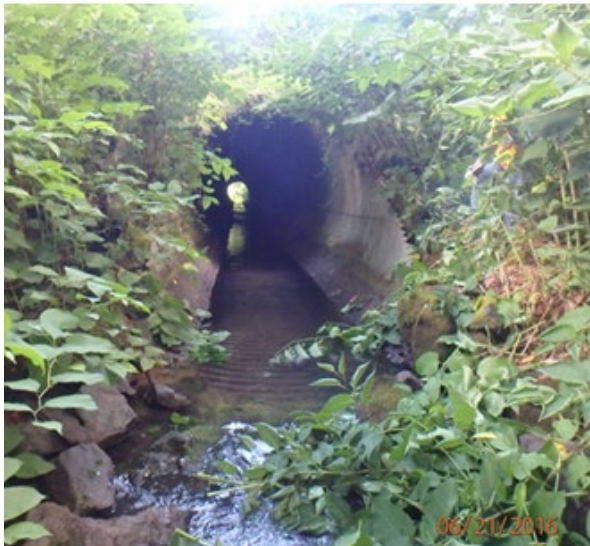
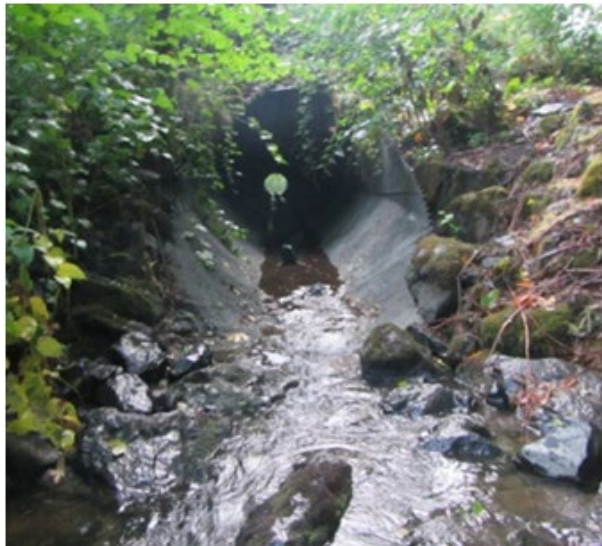
Figure 6: Pass Creek Culvert Repair Before and After

The 12-foot diameter CMP is 284 feet long and drains an area of 5.27 square miles. The culvert's surveyed condition was considered poor due to corrosion and a missing section of the invert. If left untreated, this could become a potential hazard to the traveling public due to water saturating and destabilizing the surrounding soil arch and roadbed, leading to settlement of the culvert that could leave the roadway unsupported.

The stream has an estimated active channel width of 15 feet. Water velocities during high flow conditions and shallow water depths during low flow conditions created a partial barrier for the upstream movement of fish through the culvert. Cutthroat trout, steelhead, rainbow trout, and ESA listed coho salmon were potentially blocked or delayed from accessing the approximately 4.89 miles of upstream habitat due to these conditions.

The culvert was repaired with a 6-inch paved invert treatment. This allowed for the degraded invert condition to be restored, keeping the water inside the barrel. Installing an 18-inch pre-cast concrete fish blocks at 10-foot intervals through the pipe improved fish passage. These blocks slow water velocities during high flow events, increase flow depth during low flow conditions, and create flow complexity within the culvert. The resulting conditions improve fish passage and increase access to the 4.89 miles of upstream habitat.

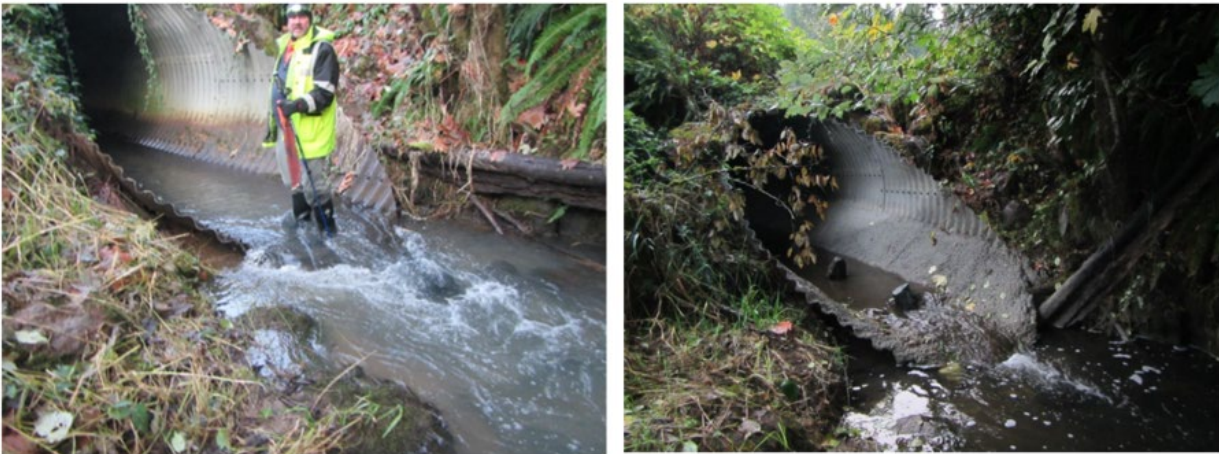
Figure 7: Pass Creek Culvert Repair Before and After

This culvert conveys Pass Creek under I-5 approximately 6.0 miles south-west of Cottage Grove in Douglas County, Oregon. Pass Creek is a tributary to Elk Creek in the Umpqua River basin. This culvert is an 8-foot circular CMP and is 234 feet long. In this location, Pass creek has an estimated active channel width of 15 feet. The culvert was considered to be in critical condition, mainly due to invert damage, water piping (water flowing on and around the outside or damaged sections of the pipe), and some end treatment issues that, if left untreated, could allow water to saturate the soil surrounding the culvert. This could cause the culvert to settle and the soil to erode, ultimately leaving the roadway unsupported.

Post-construction monitoring of the project documented that the specified rocks in the downstream weir were undersized, was not embedded into the channel, and not fully sealed, allowing water to flow through the rocks rather than maintaining surface flow. The following winter, a high water event displaced the rocks of the weir. Although subsequent high flow events recruited natural streambed material in the proximity of the original weir location, the ultimate backwater condition at the culvert outlet does not improve fish passage to the extent designed. Monitoring of the project continues to see how the natural recruitment of sediment will ultimately backwater the site. If the site does not backwater to the extent designed, a modification will be made during the applicable IWWP.

The culvert was repaired with a 6-inch paved invert. This restored the invert integrity, resolved the water piping issues, and improved the end treatment to help keep the water flowing through the culvert and not around it and in the surrounding soil. Installing 10- inch pre-cast concrete fish blocks at 5-foot intervals throughout the culvert improved fish passage. The fish blocks increase flow depths during low flow, create eddies and flow complexities within the culvert, and reduce velocities during high flow. A weir was constructed downstream of the culvert outlet to increase the outlet pool elevation and reduce the 6-inch perch, allowing for improved access to the 3.67 miles of habitat upstream.

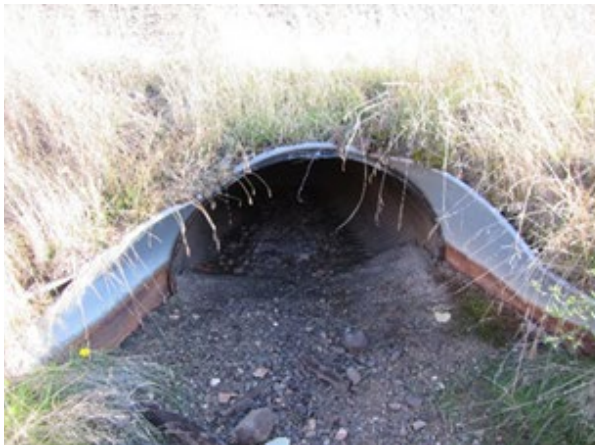
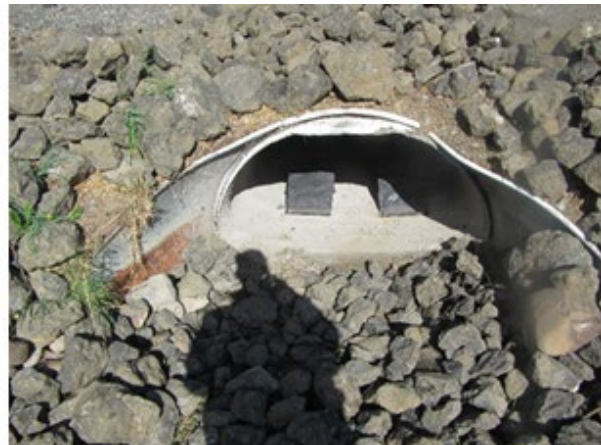
Figure 8: Unnamed Tributary to Cow Creek Culvert Repair Before and After

Description: Two images, the first looks at the end of an arch culvert pre-construction, grass growing along the top, and thin layer of sediment in the bottom. The second image is post-repair, looks at the end of the arch culvert, it is surrounded by rock with baffles installed inside.

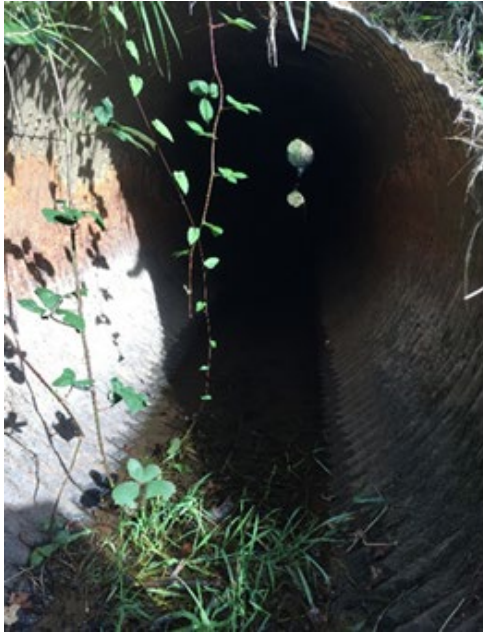
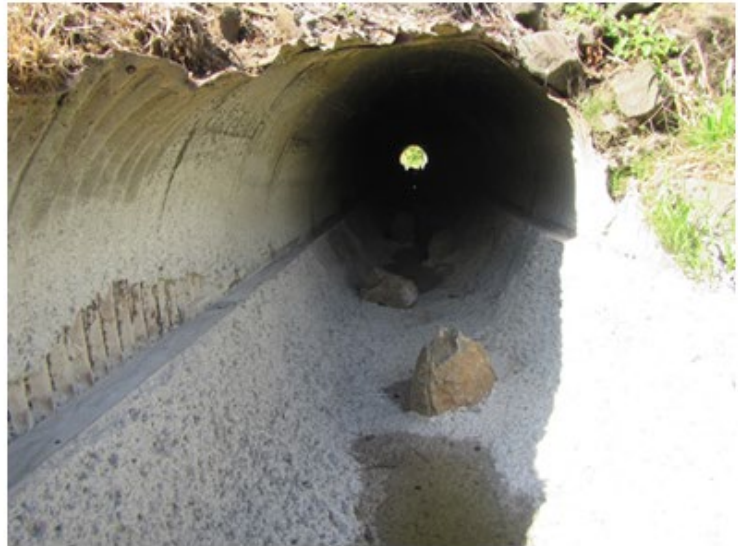
Figure 9: Unnamed Tributary to the Tillamook River Culvert Repair

Description: Two images, the first is the inside of the culvert pre-repair. The second is inside the culvert post-repair. Here we can clearly see concrete on the invert and fish rocks installed.

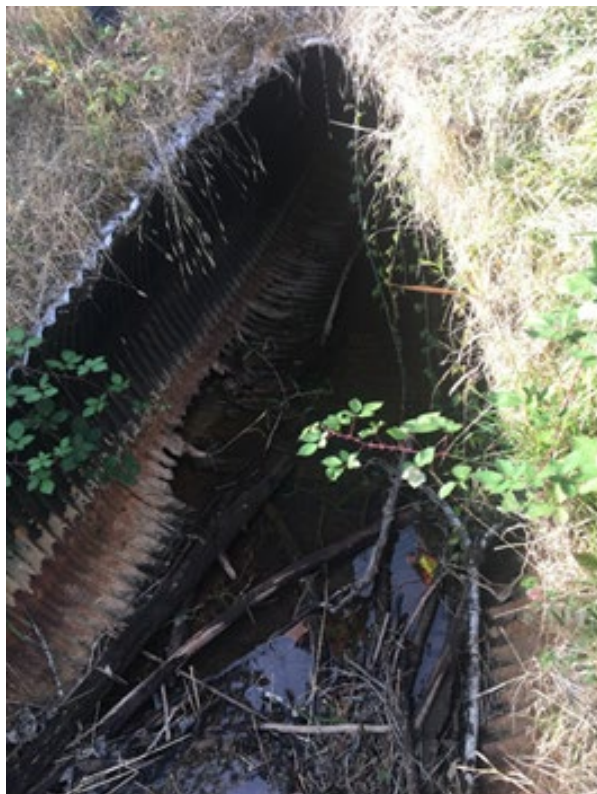
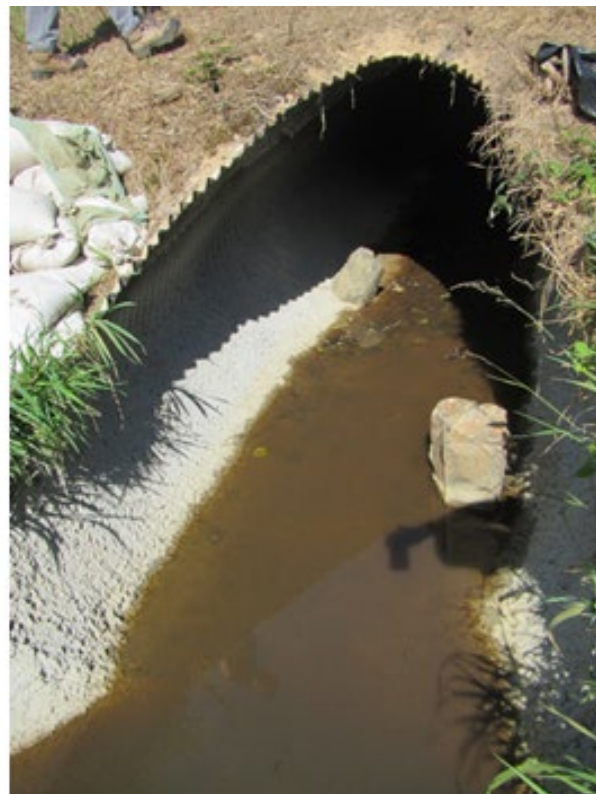
Figure 10: Unnamed Tributary to the Tillamook River Culvert Repair

Description: Two images, the first is looking down at the mitered slope end treatment pre-repair. The second is looking down at the mitered slope end treatment post repair.

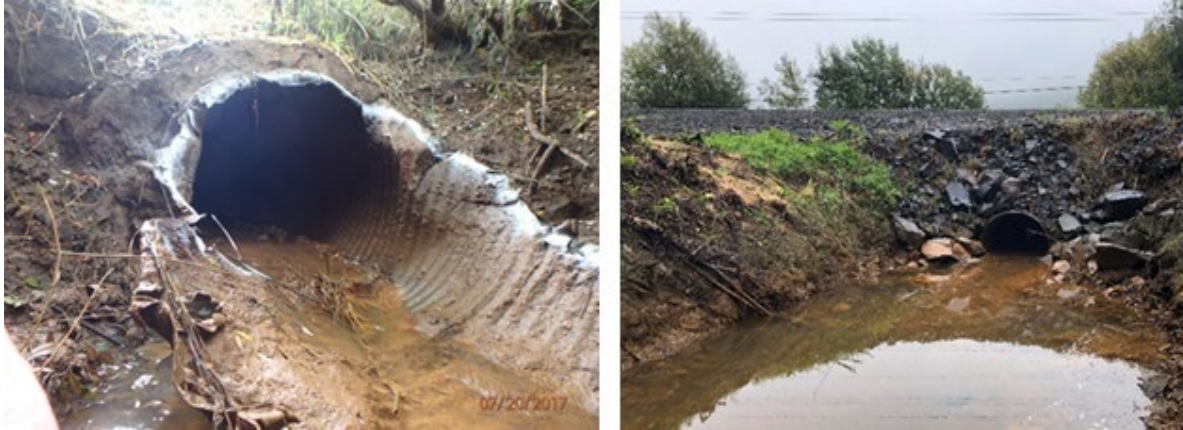
Figure 11: Tandy Creek Culvert Repair

Description: Two photos, the first shows the outlet end of the culvert recently dug out of the mud pre-repair, with water running through it. The second photo shows standing water at the post repaired outlet of the culvert.

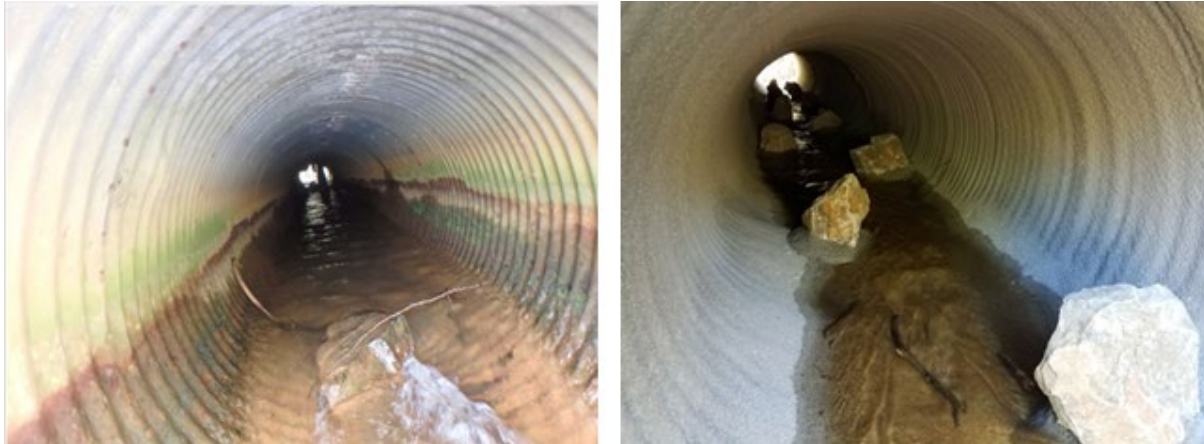
Figure 12: Baldy Creek Culvert Repair

Description: Two images, the first shows water running through the inside of the culvert pre-repair. The second image shows water running through the culvert with fish rocks post-repair.
