# Culvert Repair Programmatic Agreement (CRPA) Pilot Final Report

Report Prepared by  
William Warncke and Allen Gillette, ODOT

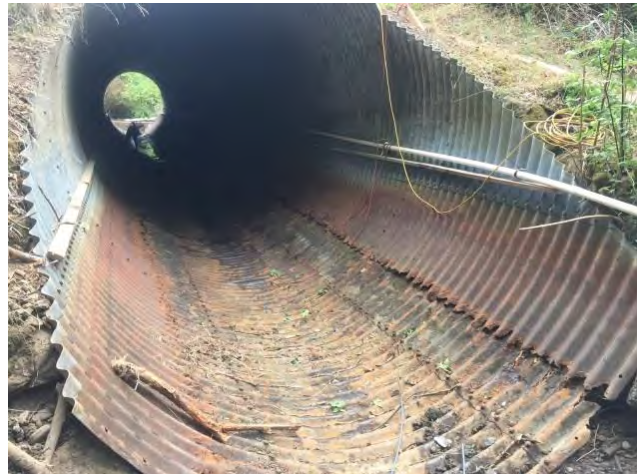
All of the 2016 culvert repair projects were repaired by invert paving. Invert paving adds a layer of reinforced concrete in the bottom of the culvert to both seal the bottom and keep water in the culvert barrel, and to provide a connection to complete the culvert circumference thereby repairing the structural capacity of the pipe. There are other repair techniques available under the CRPA but the 2016 repair locations were all metal pipes, either Corrugated Metal Pipe (CMP) or multi-plate culverts with significant invert rusting (see photo of Oakpoint Creek Culvert - to right). Several different types of fish passage improvements were included as part of these invert paving repairs (see below).

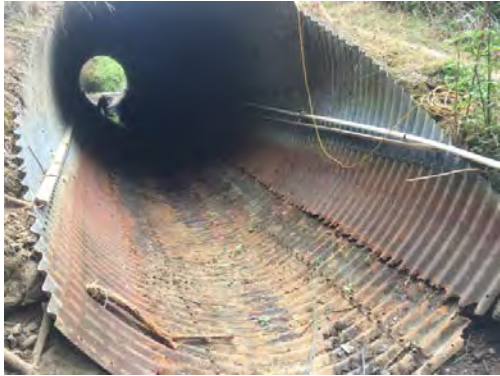
Rusted invert during construction, after the work area is isolated and culvert invert was cleaned out (10/4/16)

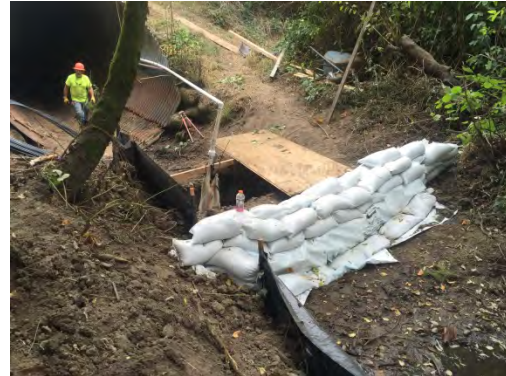
Work area isolation. The stream was not running but there were isolated pools in the channel (10/4/16)

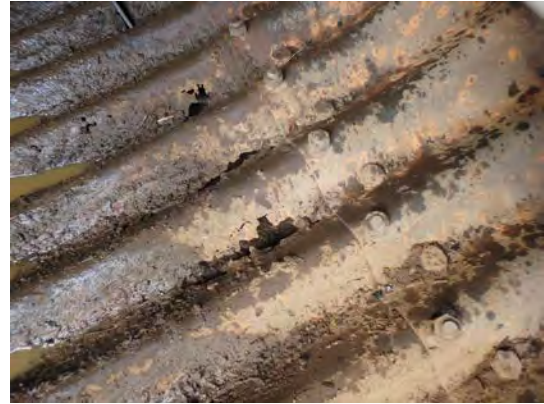
Rusted invert and voids under the culvert (9/20/16)

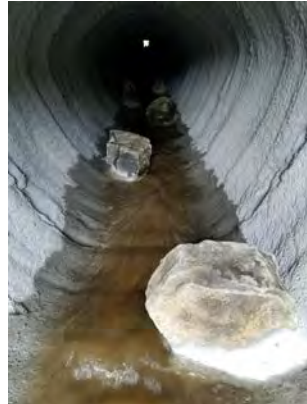
Inside culvert showing fish rocks and centrifugally cast concrete

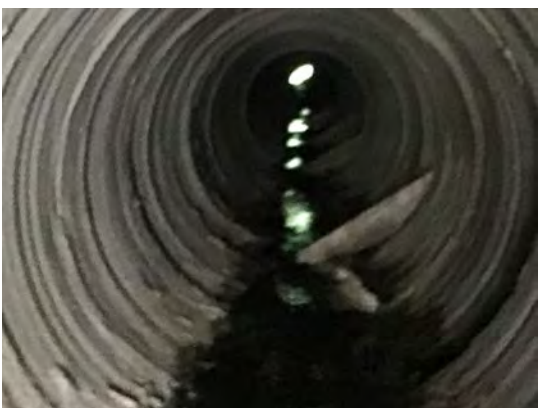
Inside culvert showing centrifugally cast concrete liner and corner baffles

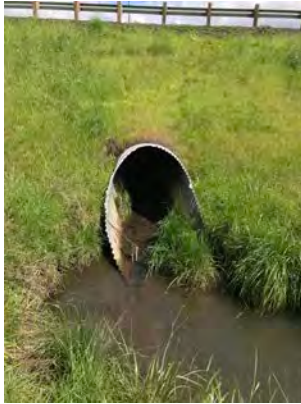
Culvert outlet before repair

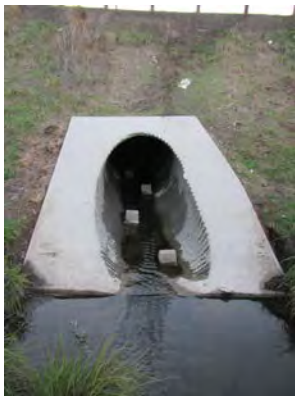
Culvert outlet after repair

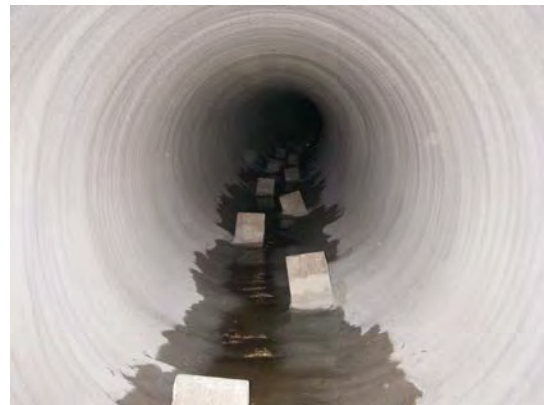
Inside culvert showing centrifugally cast concrete liner and simulated fish rocks

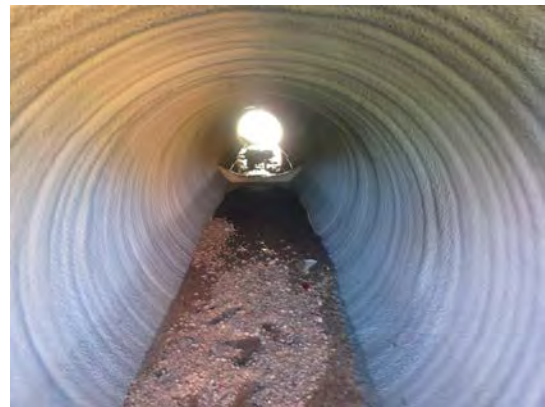
Inside of culvert showing centrifugally cast concrete liner

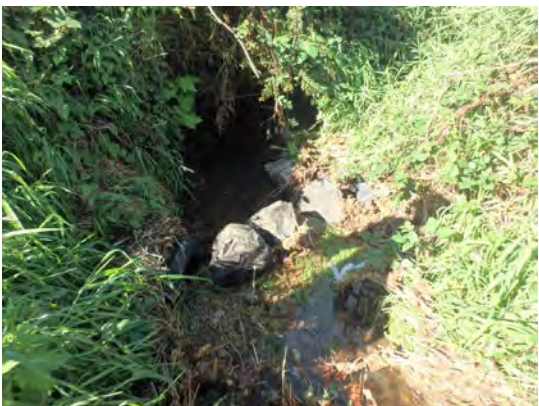
Downstream rock weir to back water up to culvert outlet
