# Underground Injection Control Facility Closure Report

Bullseye Glass Company  
3722 SE 21<sup>st</sup> Avenue  
Portland, Oregon

December 2017

**Prepared By:**  
**BRIDGEWATER GROUP**  
7100 SW Hampton St. Suite 235  
Tigard, OR 97223

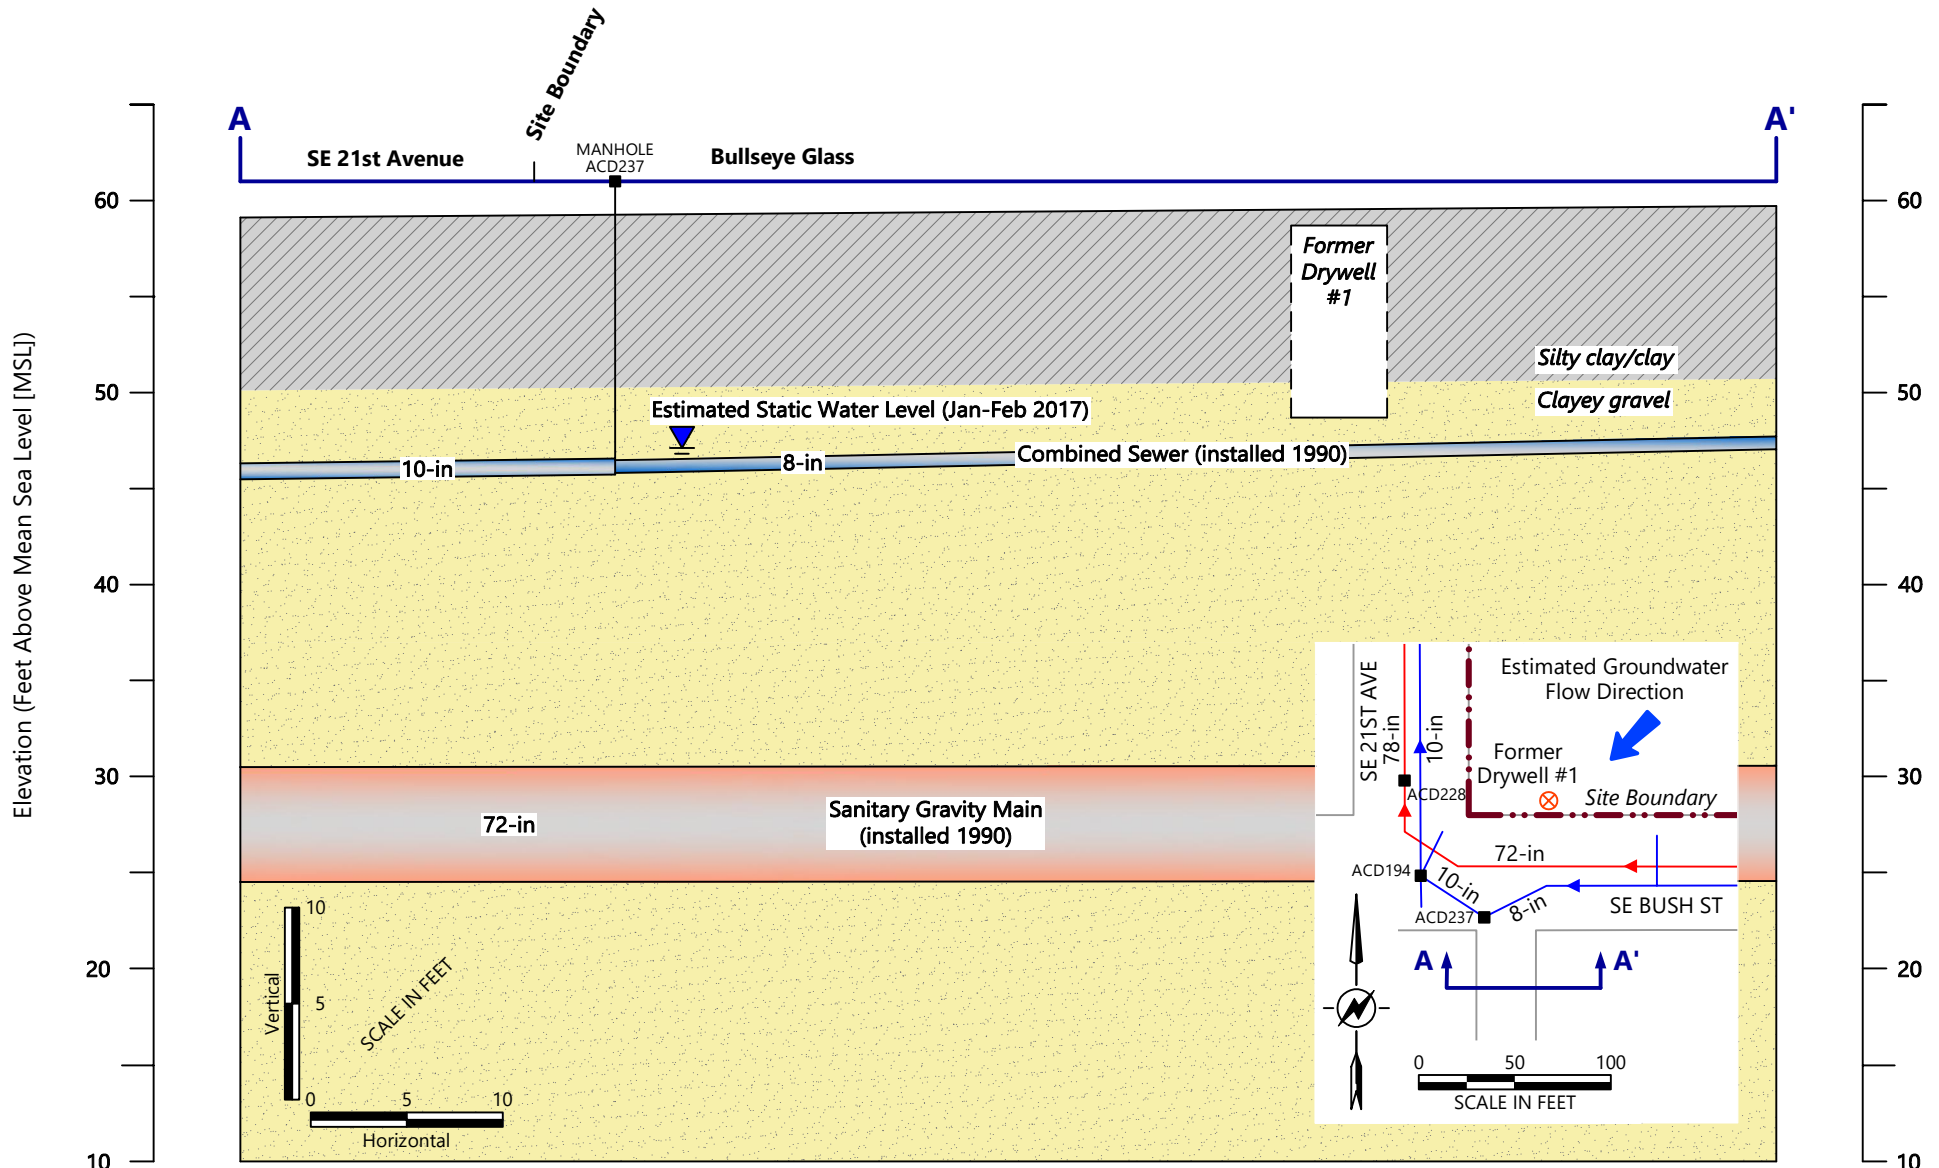
- An 8-inch diameter combined sewer that flows from manhole ACD227 east to west approximately 12-13 feet deep (elevations 50 to 46.2 ft) beneath SE Bush St; and transitions to a 10-inch diameter pipe at manhole ACD237 (elevation 46.2); then flows a short distance to manhole ACD194 (elevation 45.8) roughly in the middle of the SE 21<sup>st</sup>-SE Bush intersection; then flows 520 feet north beneath SE 21<sup>st</sup> Ave to manhole ACD189 (elevation 40.9). These lines were originally constructed circa 1911, but were partially reconstructed/relocated in 1990 (manholes and pipe runs between manhole ACD236 downstream to manhole ACD194) during construction of the “Southeast Relieving Interceptor” as discussed below (see Appendix E).

The potential for groundwater interception and longitudinal transport within the 8 and 10-inch diameter combined sewer pipe trenches, while feasible, is likely not probable given that the invert elevations of these pipeline segments are within 1-2 feet of the measured static water levels observed in temporary monitoring wells during January-February 2017. The key factors that might create a preferential pathway for groundwater migration do not appear to be present. A significant hydraulic pressure/head to create a driving migration force is not present (i.e., pipeline depths are nearly the same as the static water level elevation); the pipe bedding/trench materials used during construction likely do not have a significantly higher permeability than the surrounding native materials (i.e., Class C bedding); and the trenches are only several feet wide for small diameter pipelines. In conclusion, conditions necessary to create any significant preferential migration pathway do not appear to be present.

- A 72-inch diameter sanitary sewer referred to as the “Southeast Relieving Interceptor” flows from east to west approximately 31-32 feet beneath SE Bush St; then transitions to a south to north direction beneath SE 21<sup>st</sup> Ave. At manhole ACD228, the interceptor transitions to 78-inches in diameter. This large interceptor project was completed in southeast Portland in multiple phases during the early late 1980s through the early 1990s.

As-built drawings for the 72-inch line beneath SE Bush St indicate that this pipeline segment was constructed using traditional open-cut trenching techniques. The drawings indicate that the reinforced concrete pipe was bedded in Class B bedding material (typically ¾-inch minus crushed aggregate with well-graded distribution of fines to promote good compaction and structural support up to the spring-line of the pipe). Inasmuch as the pipe bedding and backfill material for the 72-inch pipeline might serve as a preferential pathway for groundwater movement, this movement will be stopped at manhole ACD228 from further downpipe (northward) transport since the tunneled pipeline has no preferential migration pathway around the pipe circumference, and no backfilled trench materials exist.

From review of available construction as-built drawings and video inspection documentation, it is concluded that the Southeast Relieving Interceptor does not serve as a preferential groundwater migration pathway in the vicinity of Bullseye’s former Drywell #1.

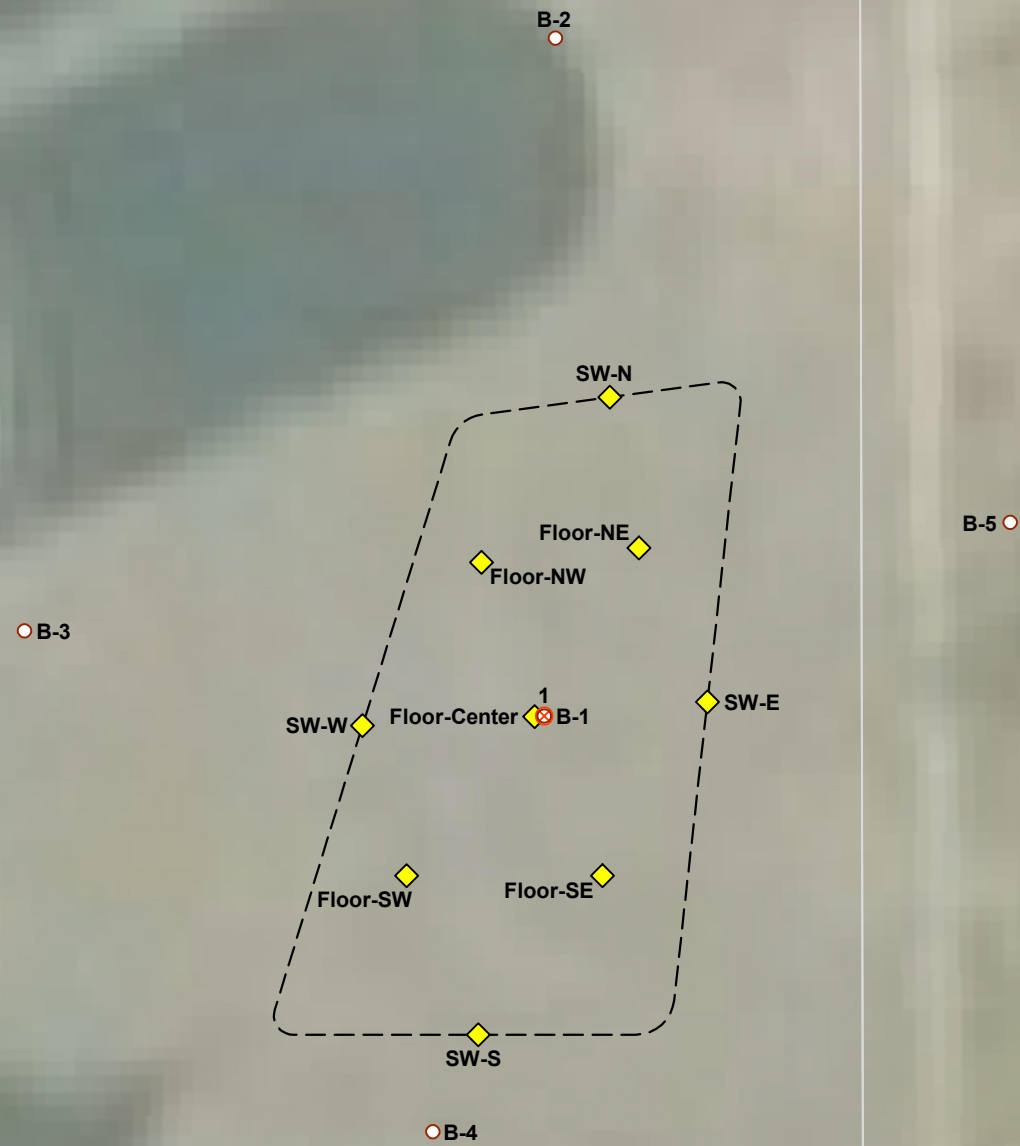
- **Arsenic.** As shown on Table 3 and Figure 4, the reported concentrations of As in the confirmation soil samples were greater than the Portland area background and the DEQ construction worker RBC, except in the west sidewall sample. The maximum observed

soil concentration was 69.6 mg/kg in the north sidewall soil sample. Arsenic was not detected in any SPLP sample result greater than an MDL of 0.05 mg/L; the EPA MCL is 0.100 mg/L. In addition, As was not detected in reconnaissance groundwater samples above the EPA MCL (see Table 4 in the *Underground Injection Control Facility Investigation Report* [Bridgewater, 2017a]).

As further described in *Underground Injection Control Facility Investigation Report* (Bridgewater, 2017a) and shown on Figure 4, As concentrations in soil samples collected from borings located around the perimeter of Drywell #1 were generally detected at or below Portland Basin background concentrations and well below DEQ's RBC for construction workers and the EPA RSL for industrial soil. Any residual As in the soils is limited.

- **Cadmium.** As shown on Table 3 and Figure 4, the reported concentrations of Cd in the confirmation samples were greater than the Portland Basin background. The concentration of Cd reported in the north sidewall sample was above the DEQ construction worker RBC for cadmium, but was below EPA's industrial soil RSL. All other Cd confirmation sample results were below the DEQ construction worker RBC.

- **Lead.** As shown on Table 3 and Figure 4, the closure verification soil samples for Pb were below the Portland Basin background concentration and below the DEQ construction worker RBC. The total lead concentrations were also below DEQ's soil to groundwater leaching RBC of 30 mg/kg and the SPLP concentrations were less than 1.5 mg/L, thereby making the 30 mg/kg RBC not applicable or relevant (i.e., lead would not be considered a leaching issue to groundwater) as described in Appendix B.3.4.3 (Special Procedures for Lead - Leaching to Groundwater) in DEQ's guidance document *Risk-Based Decision Making for the Remediation of Contaminated Sites* (DEQ, 2017).
- **Selenium.** DEQ has not established a construction worker RBC for Se. As shown on Table 3 and Figure 4, concentrations of Se in all confirmation soil samples were below EPA's industrial soil RSL.

Lastly, while residual As concentrations were greater than the DEQ construction worker RBC in all but one of the verification samples, the entire area has been repaved with 4-inch thick asphalt concrete, thereby eliminating any direct-contact exposure pathway.
