**EXHIBIT H**  
**GEOLOGY AND SEISMICITY**  
 OAR 345-021-0010(1)(h)

Archway Solar Energy LLC (Applicant) proposes to construct the Archway Solar Energy Facility (Facility) in Lake County, Oregon, with generating capacity of up to 400 megawatts (MW). The Facility may also contain a battery energy component with storage capacity of up to 400 MW and discharge capacity of up to 1,600 megawatt-hours. This Exhibit presents an analysis of the Facility geology and seismicity, as required by OAR 345-021-0010(1)(h).

# Preliminary Geotechnical Engineering Report

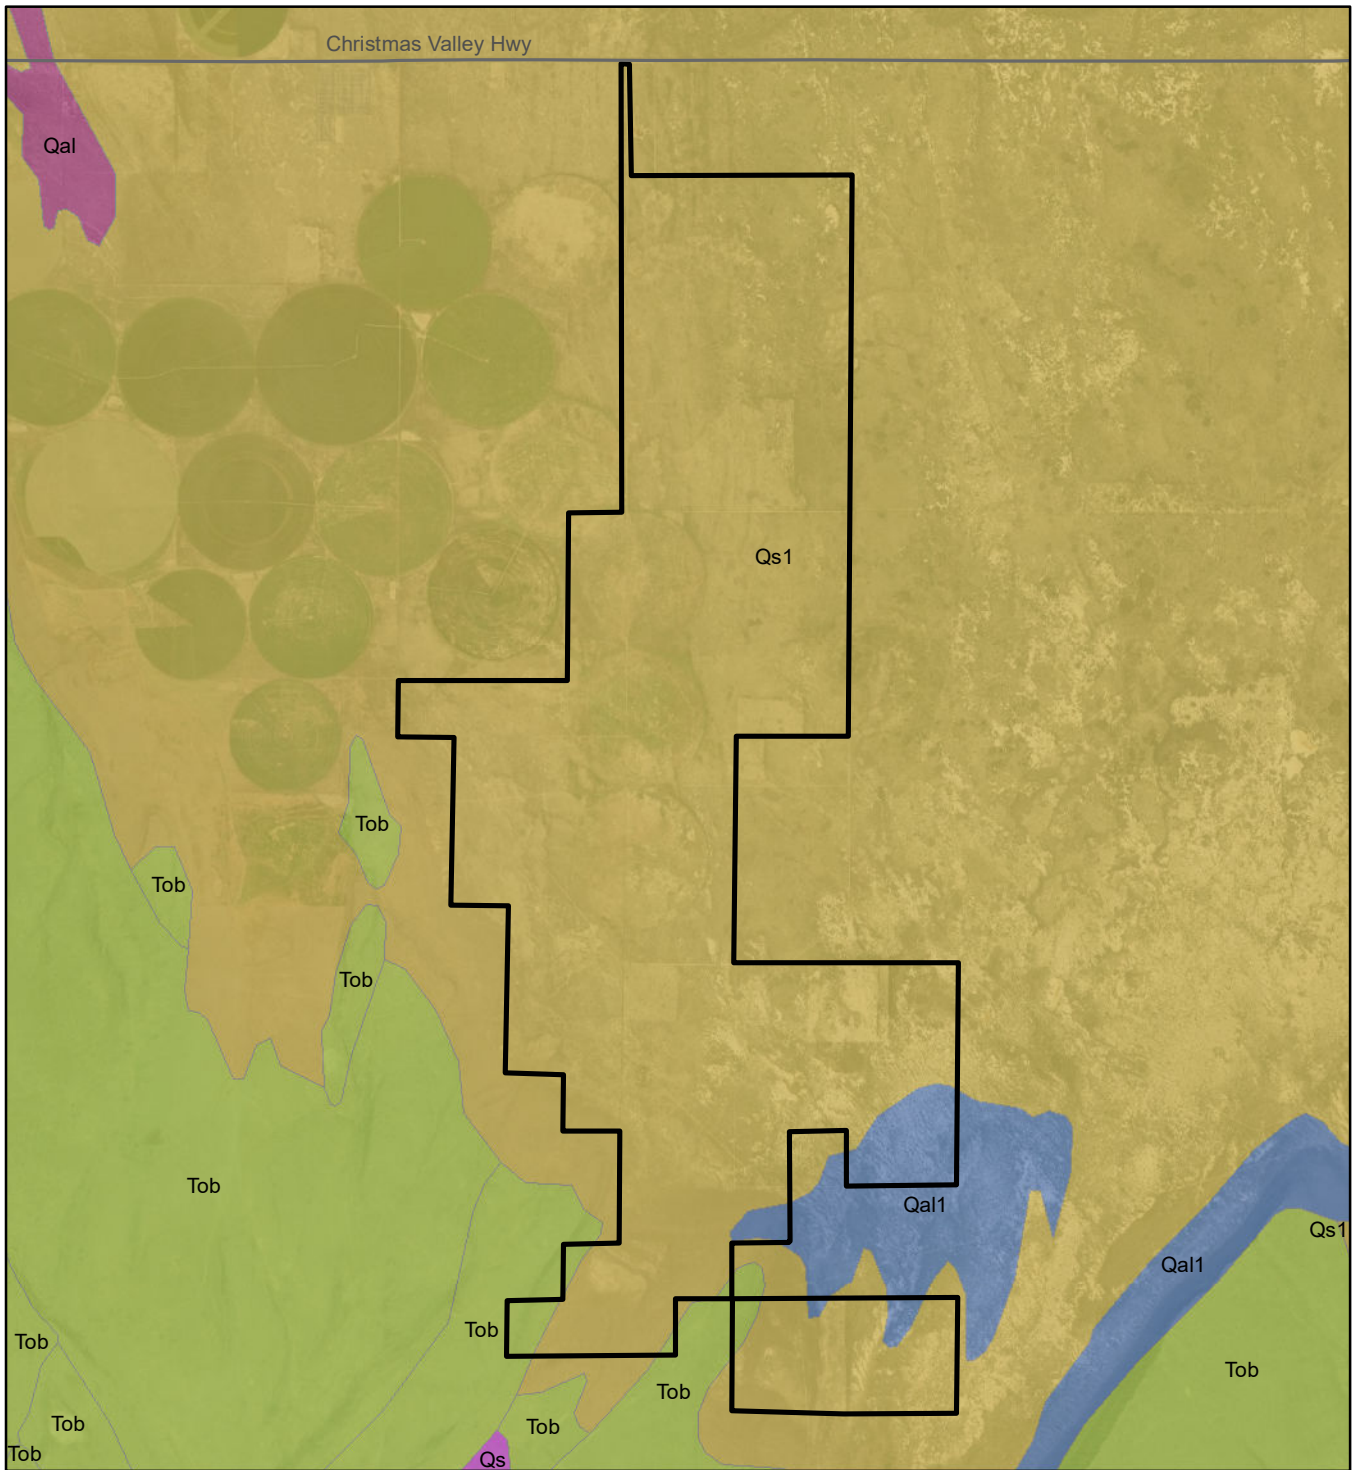
**Figure H-1  
Geology Map**  
Application for Site Certificate  
Archway Solar Energy Facility  
Lake County, Oregon

The following descriptions of the geologic units found in the area are summarized from Franczyk et al. (2021) and Diggles et al. (1990) and from the Facility-specific preliminary geotechnical work performed by Terracon and included as Attachment H-1 (Terracon 2020).

As described by Terracon (2020), the majority of the Facility site is mapped as Quaternary sediments (Qs), known as diatomaceous earth, which can be further defined as a soft, crumbly, porous sedimentary deposit formed from the fossil remains of diatoms (see Attachment H-1). Diatoms are a type of algae found at the bottom of a body of water, which is consistent for an area historically covered by an inland sea. The Terracon report further states that diatomaceous soil is often characterized by high water contents, low unit weights, and susceptibility to crumbling.

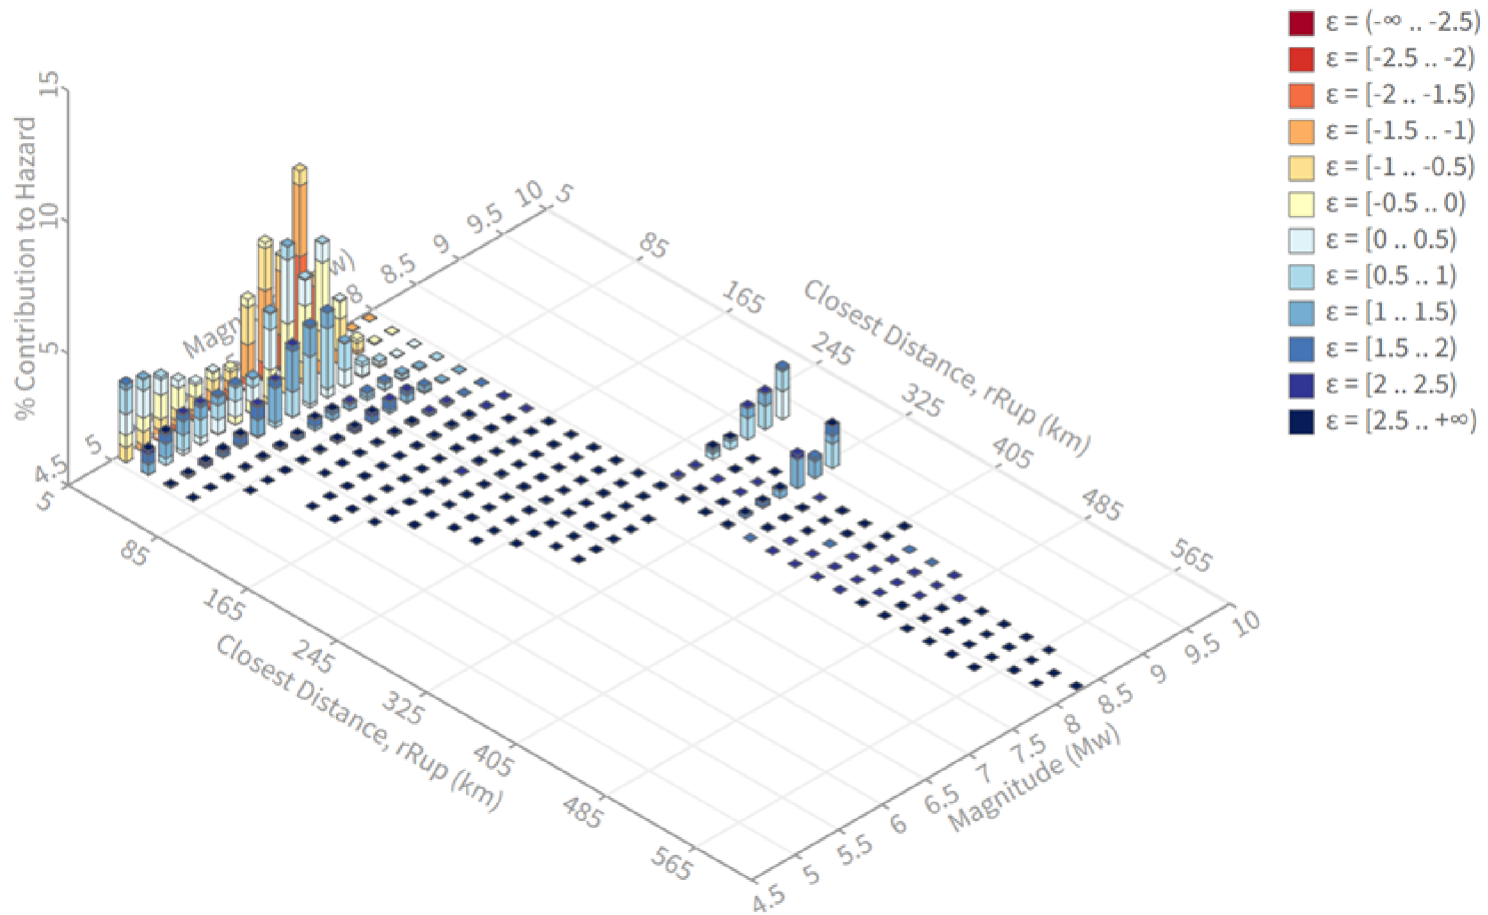
**Figure H-3**  
**Probabilistic Seismic Hazard Deaggregation for the Maximum Probable Earthquake Event**  
 Application for Site Certificate  
 Archway Solar Energy Facility  
 Lake County, Oregon

PSH Deaggregation on NEHRP BC Rock  
 Invenergy Archway Solar: 43.200° N, 120.453° W  
 Mean Return Period: 475 years  
 Peak Horizontal Ground Acceleration: 0.1250 g

The Maximum Probable Earthquake (MPE) is considered to be an earthquake that has a 10 percent probability of exceedance in 50 years (a nominal 475-year recurrence interval). The MConE is considered to be an earthquake with a nominal 2,475-year recurrence interval (a 2 percent probability of exceedance in 50 years). Figures H-3 and H-4 show the probabilistic seismic hazard deaggregation for the MPE and MConE events, respectively.

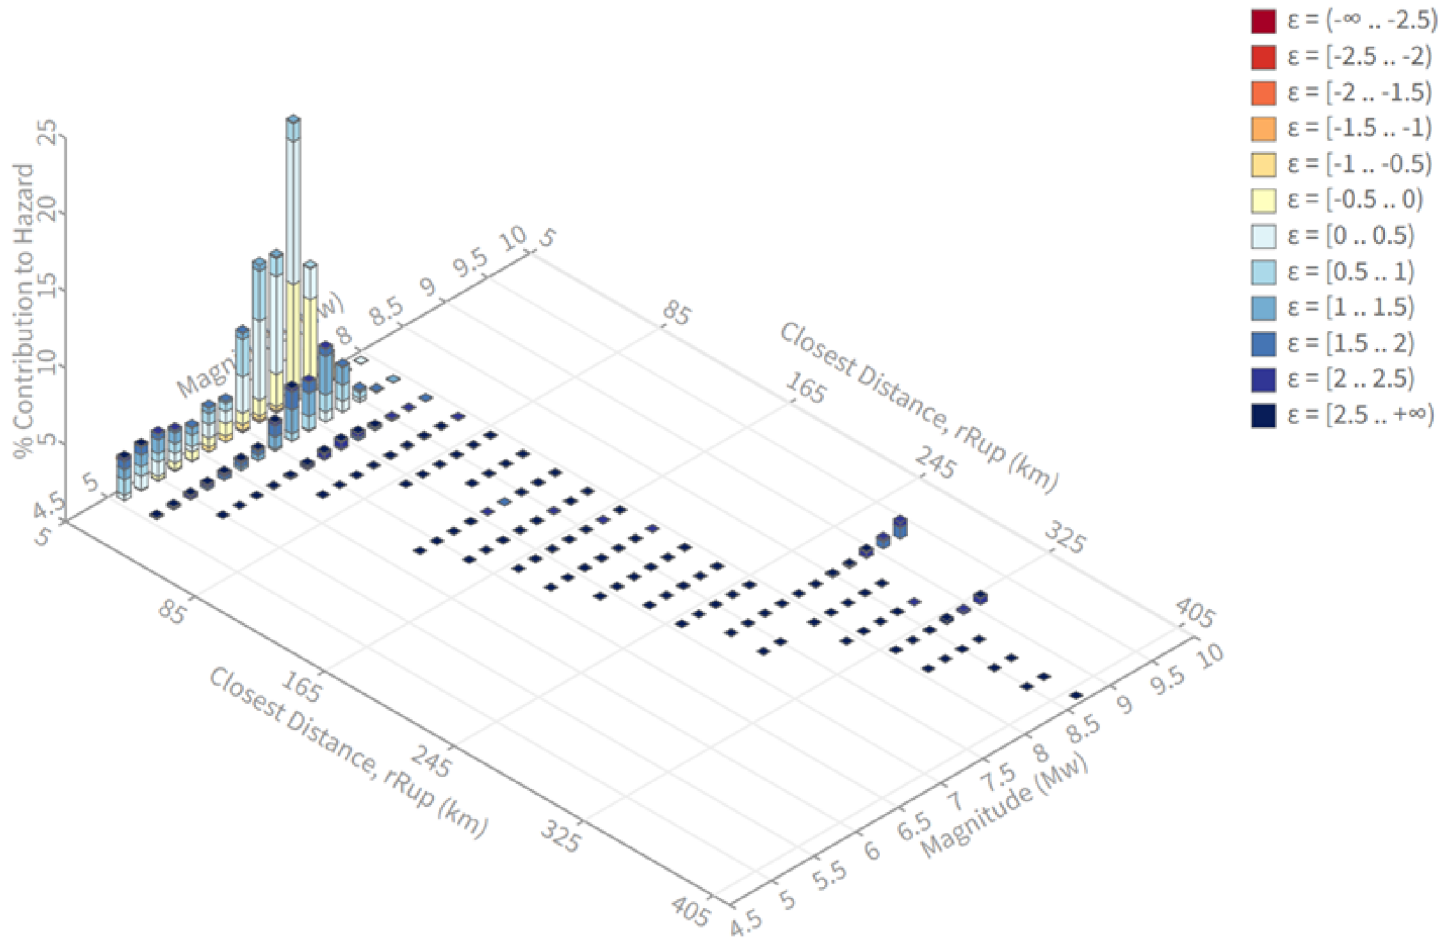
**Figure H-4**  
**Probabilistic Seismic Hazard Deaggregation for the Maximum Considered Earthquake Event**  
 Application for Site Certificate  
 Archway Solar Energy Facility  
 Lake County, Oregon

PSH Deaggregation on NEHRP BC Rock  
 Invenergy Archway Solar: 43.200° N, 120.453° W  
 Mean Return Period: 2,475 years  
 Peak Horizontal Ground Acceleration: 0.2938 g

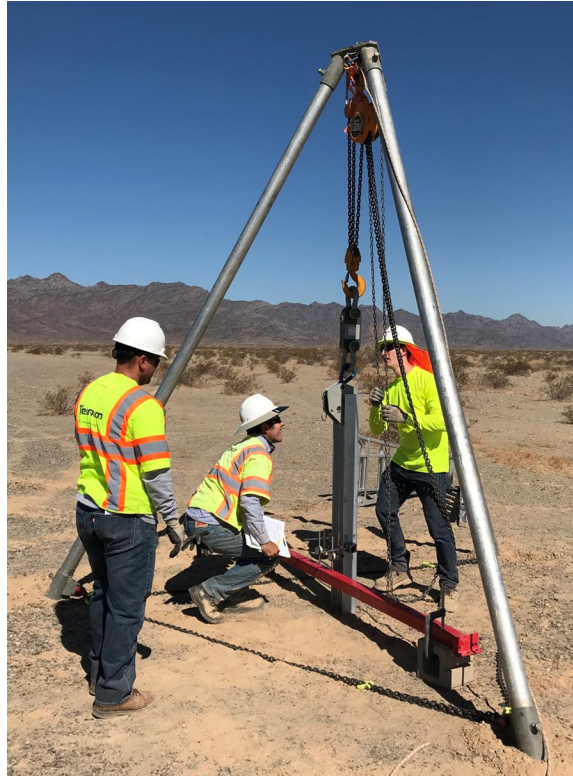
The following photograph shows a typical axial tensile load test pile arrangement using the tripod system:

**Typical Photo of Tripod with Chain Fall, Load Cell, and Dial Gauges.**

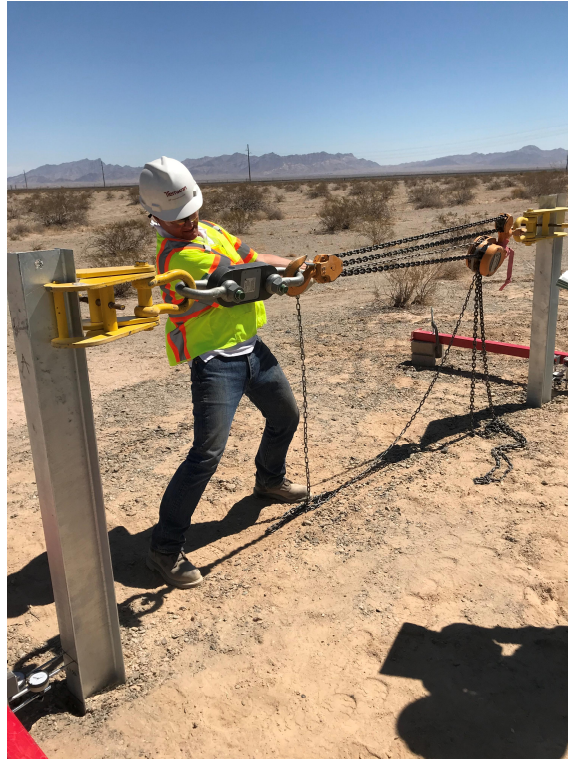
The following photograph shows a typical arrangement of two piles connected together for a lateral load test:

**Typical Photo of Load Cell Connected to Two Test Piles.**

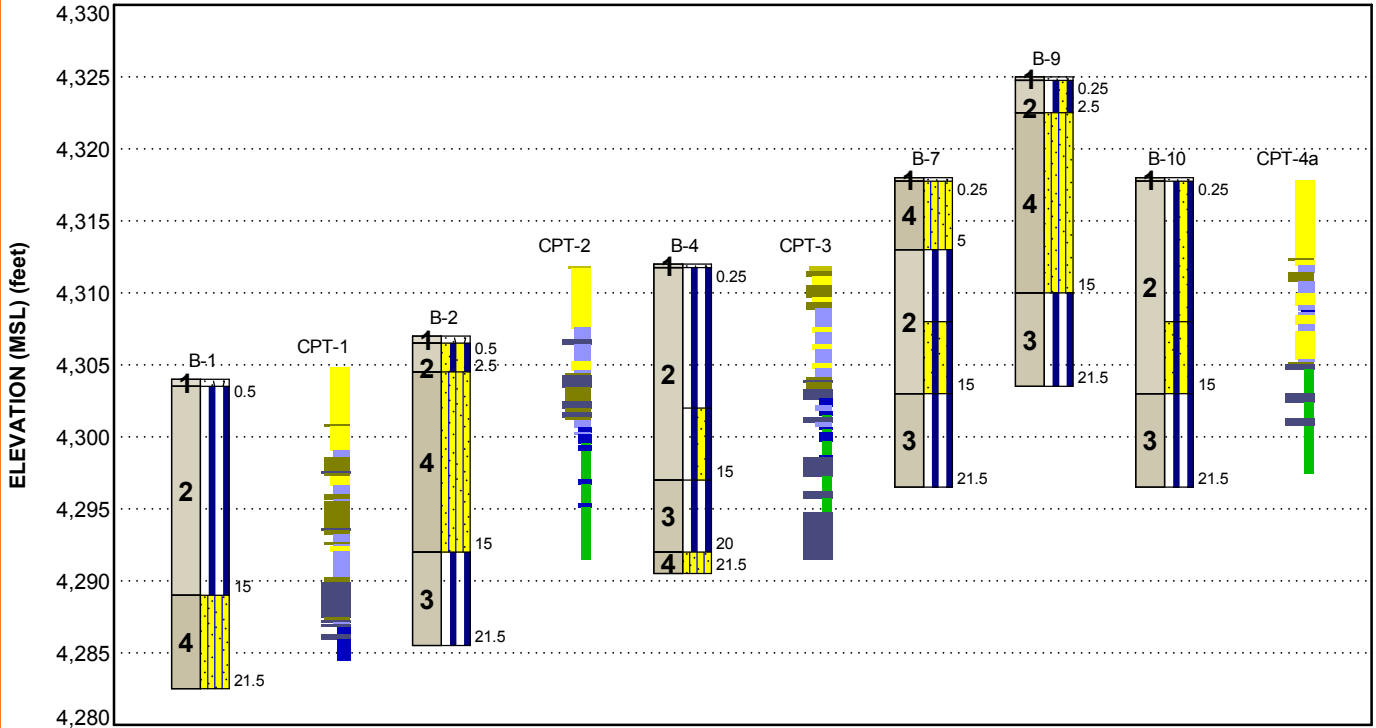
# GEOMODEL

This is not a cross section. This is intended to display the Geotechnical Model only. See individual logs for more detailed conditions.

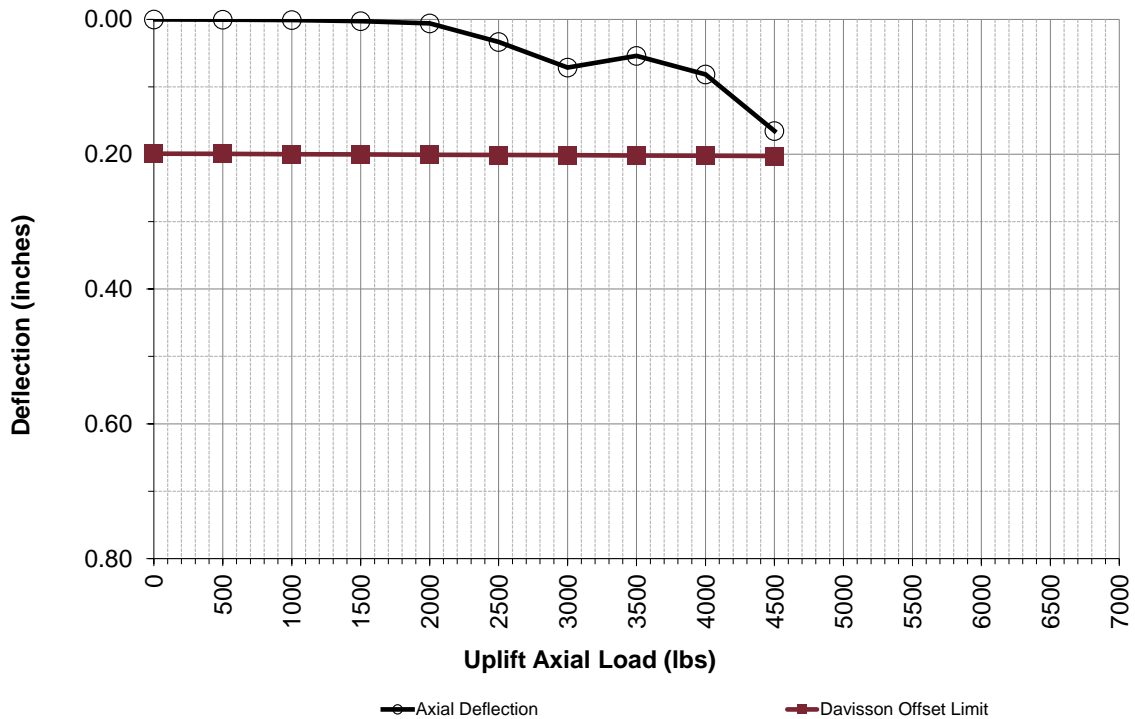
# Tension Load Test Result for PLT-1, 8ft. Embedment

Tension Test Results			Davisson Offset Limit Lines		
% of Design Load	Axial Load [lbs]	Deflection Δ (in.) Gauges #1 & #2	Elastic Data (in) (PL/AE)	Davisson Offset Limit (in) (0.15+D/120+(PL/AE))	Comments
0%	0	0.000	0.000	0.199	
7%	500	0.000	0.000	0.200	
14%	1000	0.001	0.001	0.200	
21%	1500	0.002	0.001	0.200	
29%	2000	0.006	0.002	0.201	
36%	2500	0.034	0.002	0.201	
43%	3000	0.072	0.002	0.201	
50%	3500	0.054	0.003	0.202	
57%	4000	0.081	0.003	0.202	
64%	4500	0.166	0.003	0.203	
71%	5000		0.004		
79%	5500		0.004		
86%	6000		0.005		
93%	6500		0.005		
100%	7000		0.005

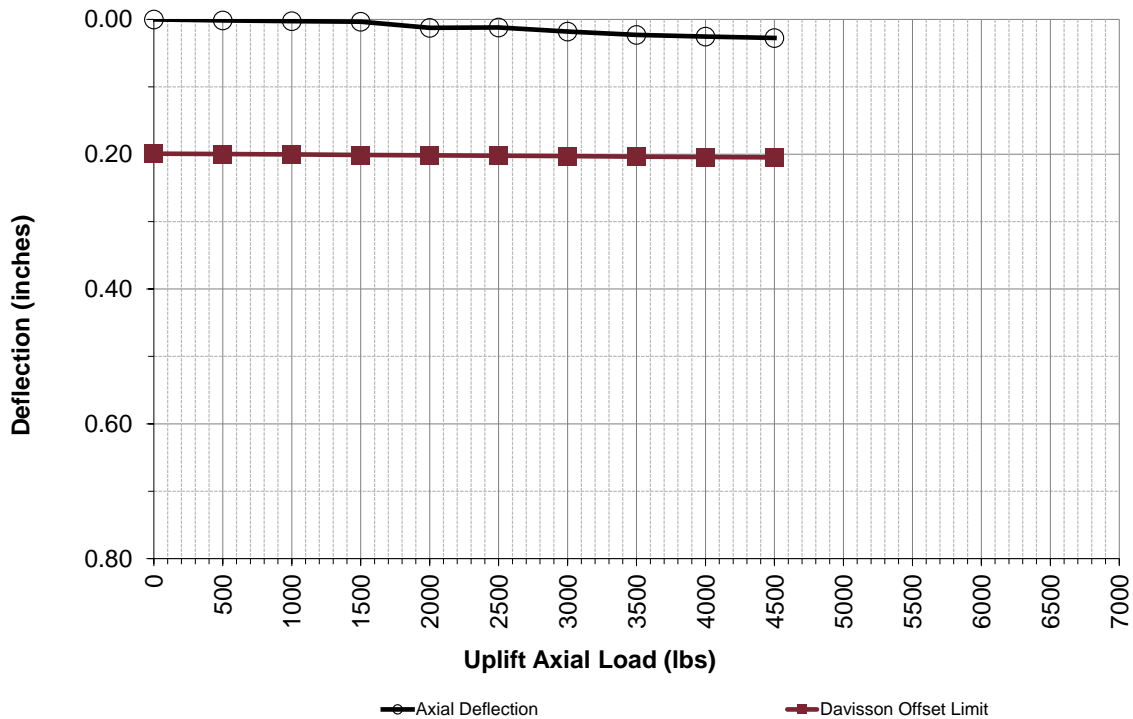
# Tension Load Test Result for PLT-2, 5ft. Embedment

Tension Test Results			Davisson Offset Limit Lines		
% of Design Load	Axial Load [lbs]	Deflection Δ (in.) Gauges #1 & #2	Elastic Data (in) (PL/AE)	Davisson Offset Limit (in) (0.15+D/120+(PL/AE))	Comments
0%	0	0.000	0.000	0.199	
7%	500	0.002	0.001	0.200	
14%	1000	0.003	0.001	0.200	
21%	1500	0.004	0.002	0.201	
29%	2000	0.013	0.002	0.202	
36%	2500	0.012	0.003	0.202	
43%	3000	0.018	0.004	0.203	
50%	3500	0.023	0.004	0.203	
57%	4000	0.026	0.005	0.204	
64%	4500	0.028	0.006	0.205	
71%	5000		0.006		
79%	5500		0.007		
86%	6000		0.007		
93%	6500		0.008		
100%	7000		0.009

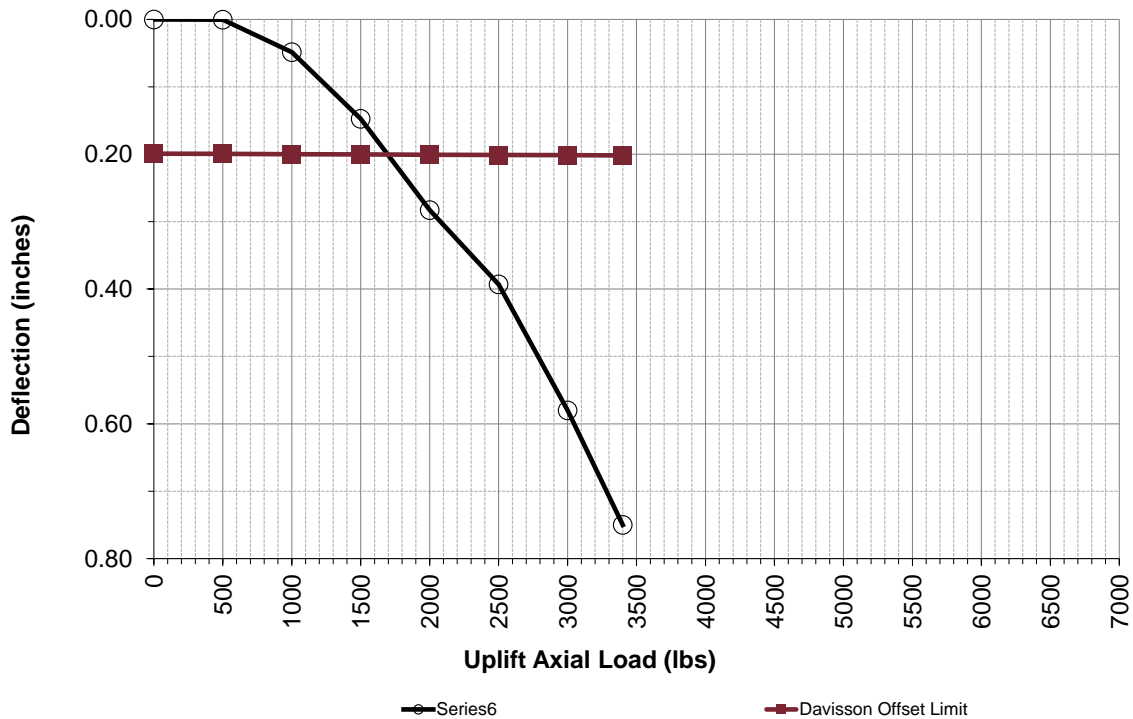
# Tension Load Test Result for PLT-2, 8ft. Embedment

Tension Test Results			Davisson Offset Limit Lines		
% of Design Load	Axial Load [lbs]	Deflection Δ (in.) Gauges #1 & #2	Elastic Data (in) (PL/AE)	Davisson Offset Limit (in) (0.15+D/120+(PL/AE))	Comments
0%	0	0.000	0.000	0.199	
7%	500	0.001	0.000	0.200	
14%	1000	0.049	0.001	0.200	
21%	1500	0.148	0.001	0.200	
29%	2000	0.283	0.002	0.201	
36%	2500	0.393	0.002	0.201	
43%	3000	0.580	0.002	0.201	
49%	3400	0.750	0.003	0.202	
57%	4000		0.003		
63%	4400		0.003		
71%	5000		0.004		
79%	5500		0.004		
86%	6000		0.005		
93%	6500		0.005		
100%	7000		0.005

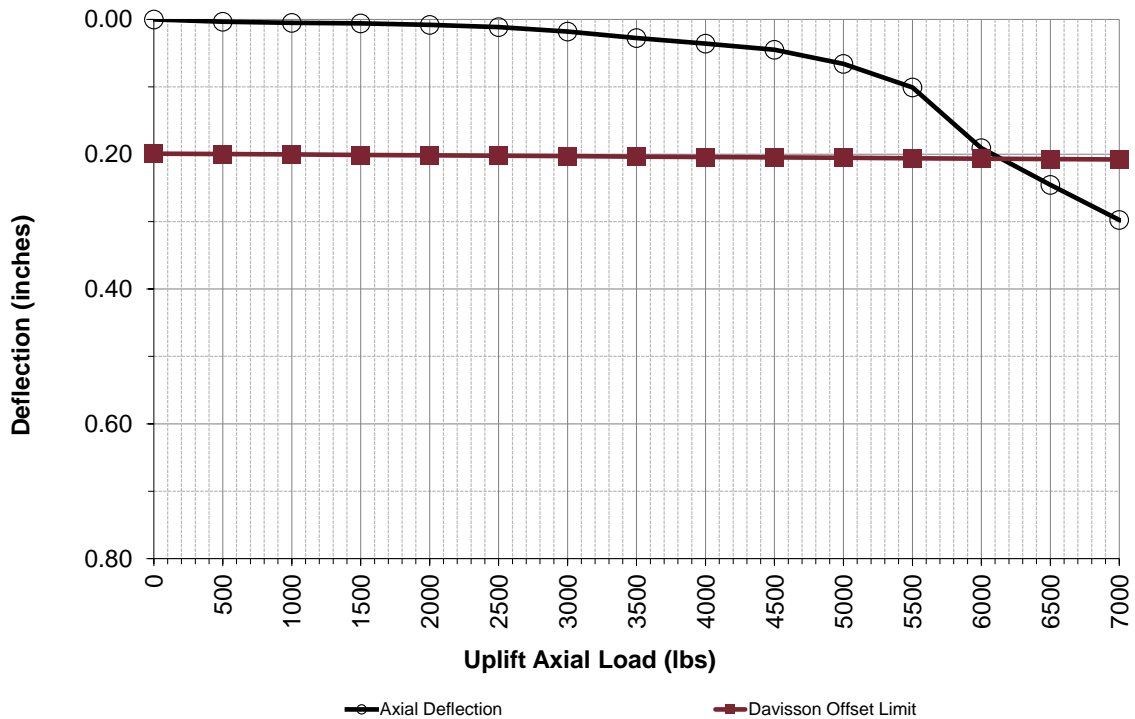
# Tension Load Test Result for PLT-3, 5ft. Embedment

Tension Test Results			Davisson Offset Limit Lines		
% of Design Load	Axial Load [lbs]	Deflection Δ (in.) Gauges #1 & #2	Elastic Data (in) (PL/AE)	Davisson Offset Limit (in) (0.15+D/120+(PL/AE))	Comments
0%	0	0.000	0.000	0.199	
7%	500	0.003	0.001	0.200	
14%	1000	0.005	0.001	0.200	
21%	1500	0.006	0.002	0.201	
29%	2000	0.008	0.002	0.202	
36%	2500	0.012	0.003	0.202	
43%	3000	0.018	0.004	0.203	
50%	3500	0.028	0.004	0.203	
57%	4000	0.036	0.005	0.204	
64%	4500	0.045	0.006	0.205	
71%	5000	0.066	0.006	0.205	
79%	5500	0.101	0.007	0.206	
86%	6000	0.191	0.007	0.207	
93%	6500	0.246	0.008	0.207	
100%	7000	0.298	0.009	0.208

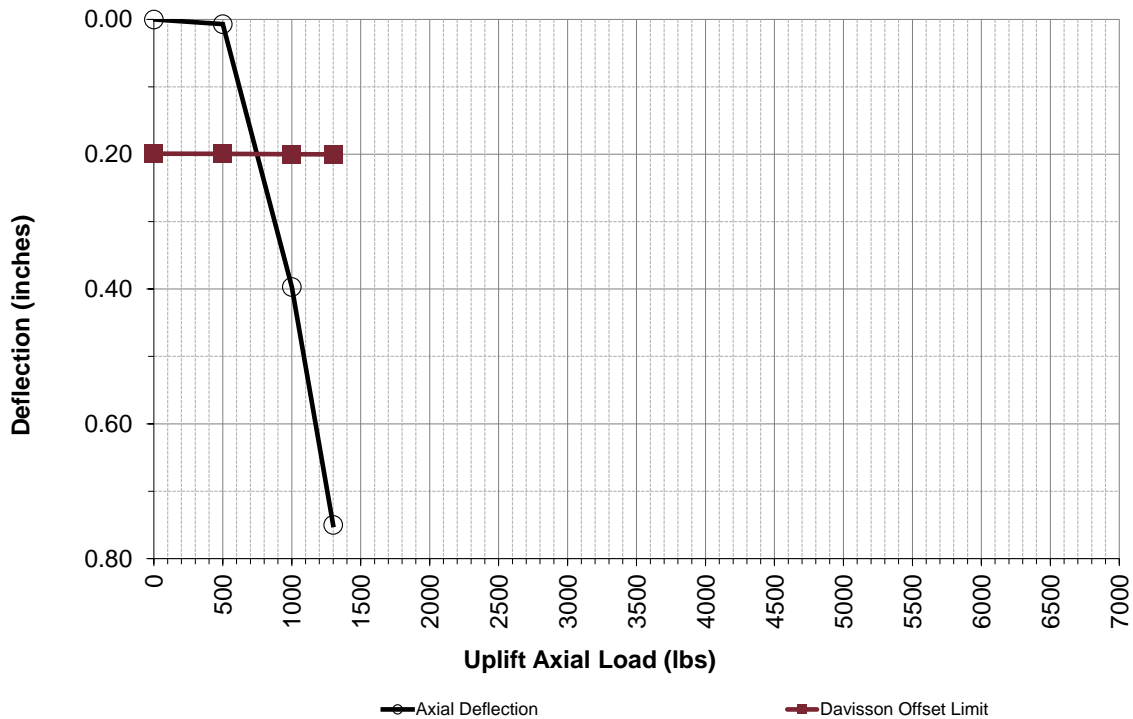
# Tension Load Test Result for PLT-3, 8ft. Embedment

Tension Test Results			Davisson Offset Limit Lines		
% of Design Load	Axial Load [lbs]	Deflection Δ (in.) Gauges #1 & #2	Elastic Data (in) (PL/AE)	Davisson Offset Limit (in) (0.15+D/120+(PL/AE))	Comments
0%	0	0.000	0.000	0.199	
7%	500	0.007	0.000	0.200	
14%	1000	0.397	0.001	0.200	
19%	1300	0.750	0.001	0.200	
29%	2000		0.002		
36%	2500		0.002		
43%	3000		0.002		
50%	3500		0.003		
57%	4000		0.003		
64%	4500		0.003		
71%	5000		0.004		
79%	5500		0.004		
86%	6000		0.005		
93%	6500		0.005		
100%	7000		0.005

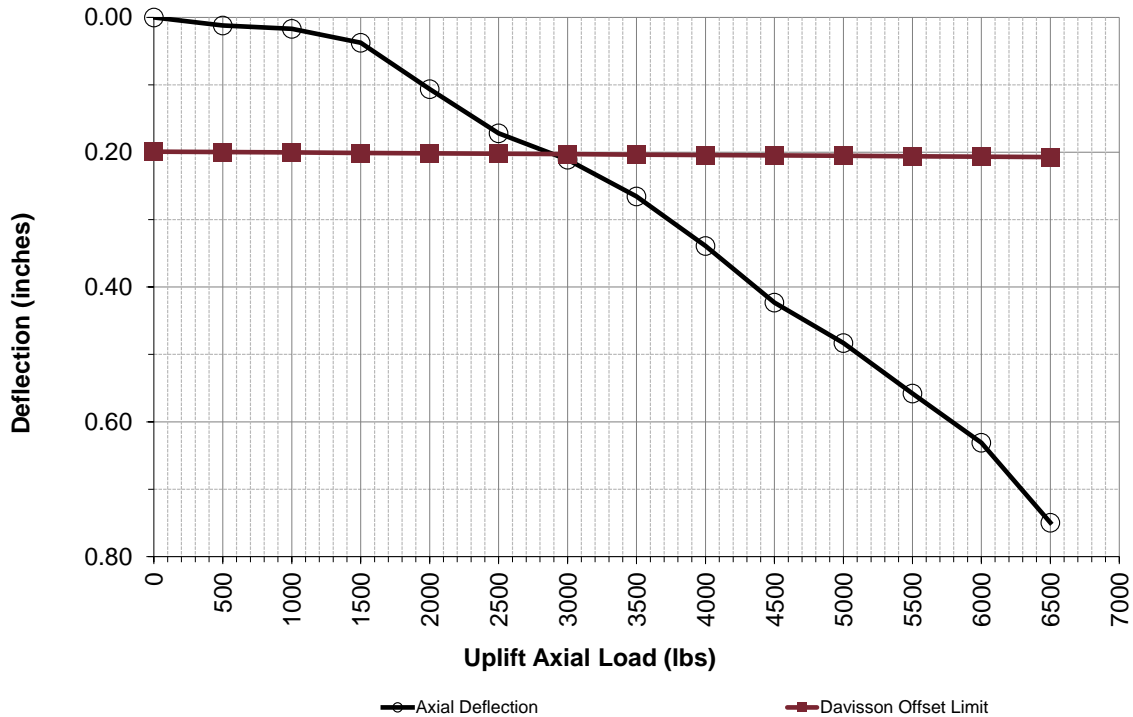
# Tension Load Test Result for PLT-4, 5ft. Embedment

Tension Test Results			Davisson Offset Limit Lines		Comments
% of Design Load	Axial Load [lbs]	Deflection Δ (in.) Gauges #1 & #2	Elastic Data (in) (PL/AE)	Davisson Offset Limit (in) (0.15+D/120+(PL/AE))	
0%	0	0.000	0.000	0.199	
7%	500	0.012	0.001	0.200	
14%	1000	0.017	0.001	0.200	
21%	1500	0.037	0.002	0.201	
29%	2000	0.107	0.002	0.202	
36%	2500	0.172	0.003	0.202	
43%	3000	0.211	0.004	0.203	
50%	3500	0.266	0.004	0.203	
57%	4000	0.339	0.005	0.204	
64%	4500	0.423	0.006	0.205	
71%	5000	0.483	0.006	0.205	
79%	5500	0.558	0.007	0.206	
86%	6000	0.631	0.007	0.207	
93%	6500	0.750	0.008	0.207	
100%	7000		0.009

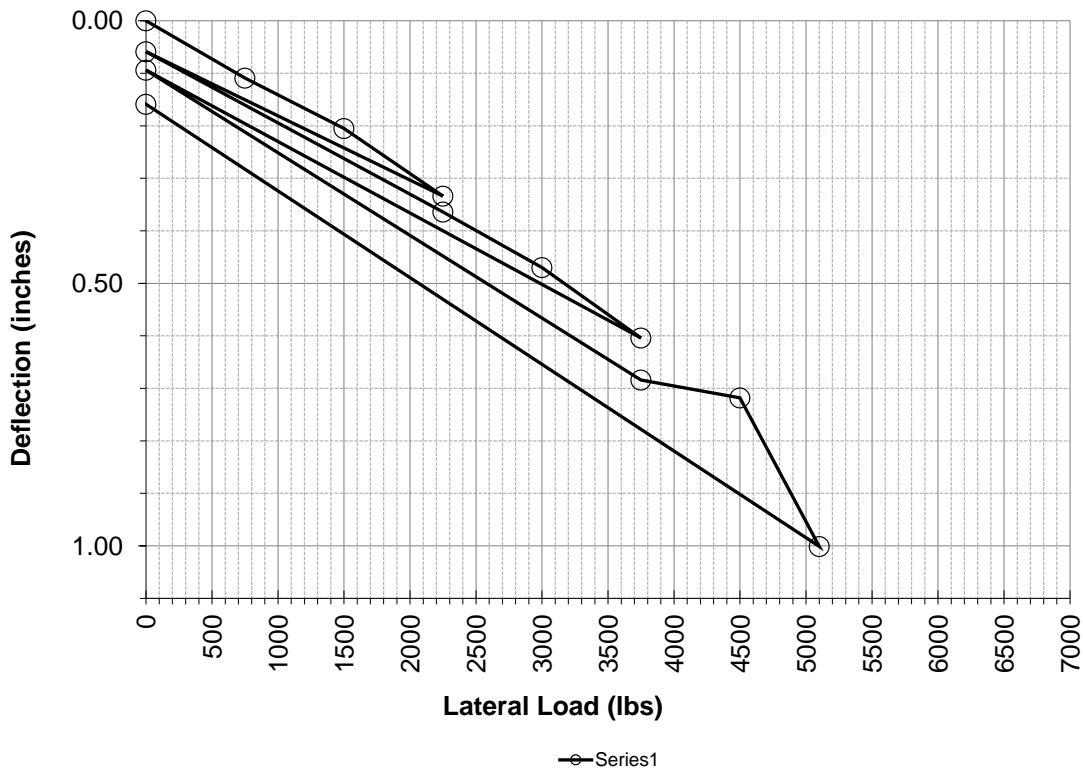
Pile ID: PLT-4, 12ft  
 Latitude: 43.16221  
 Longitude: -120.45297  
 Pile Type: W6x9  
 Pile Embedment Depth [in]: 96  
 Pile Stick-Up [in]: 48  
 Lateral Design Load [lbs]: 7000  
 Drive Time [sec]: 30

% of Design Load	Lateral Load [lbs]	Deflection Δ (in.) Gauge #1	Comments
0%	0	0.000	
11%	750	0.109	
21%	1500	0.205	
32%	2250	0.334	
0%	0	0.059	
32%	2250	0.364	
43%	3000	0.470	
54%	3750	0.604	
0%	0	0.094	
54%	3750	0.684	
64%	4500	0.718	
73%	5100	1.001	
0%	0	0.159	
75%	5250		
86%	6000		
100%	7000		
0%	0
