SAFETY INVESTIGATION MANUAL WORKSHEET

CASE STUDY: US-20 AND BARCLAY DR

Case Study #2: US-20 and Barclay Dr

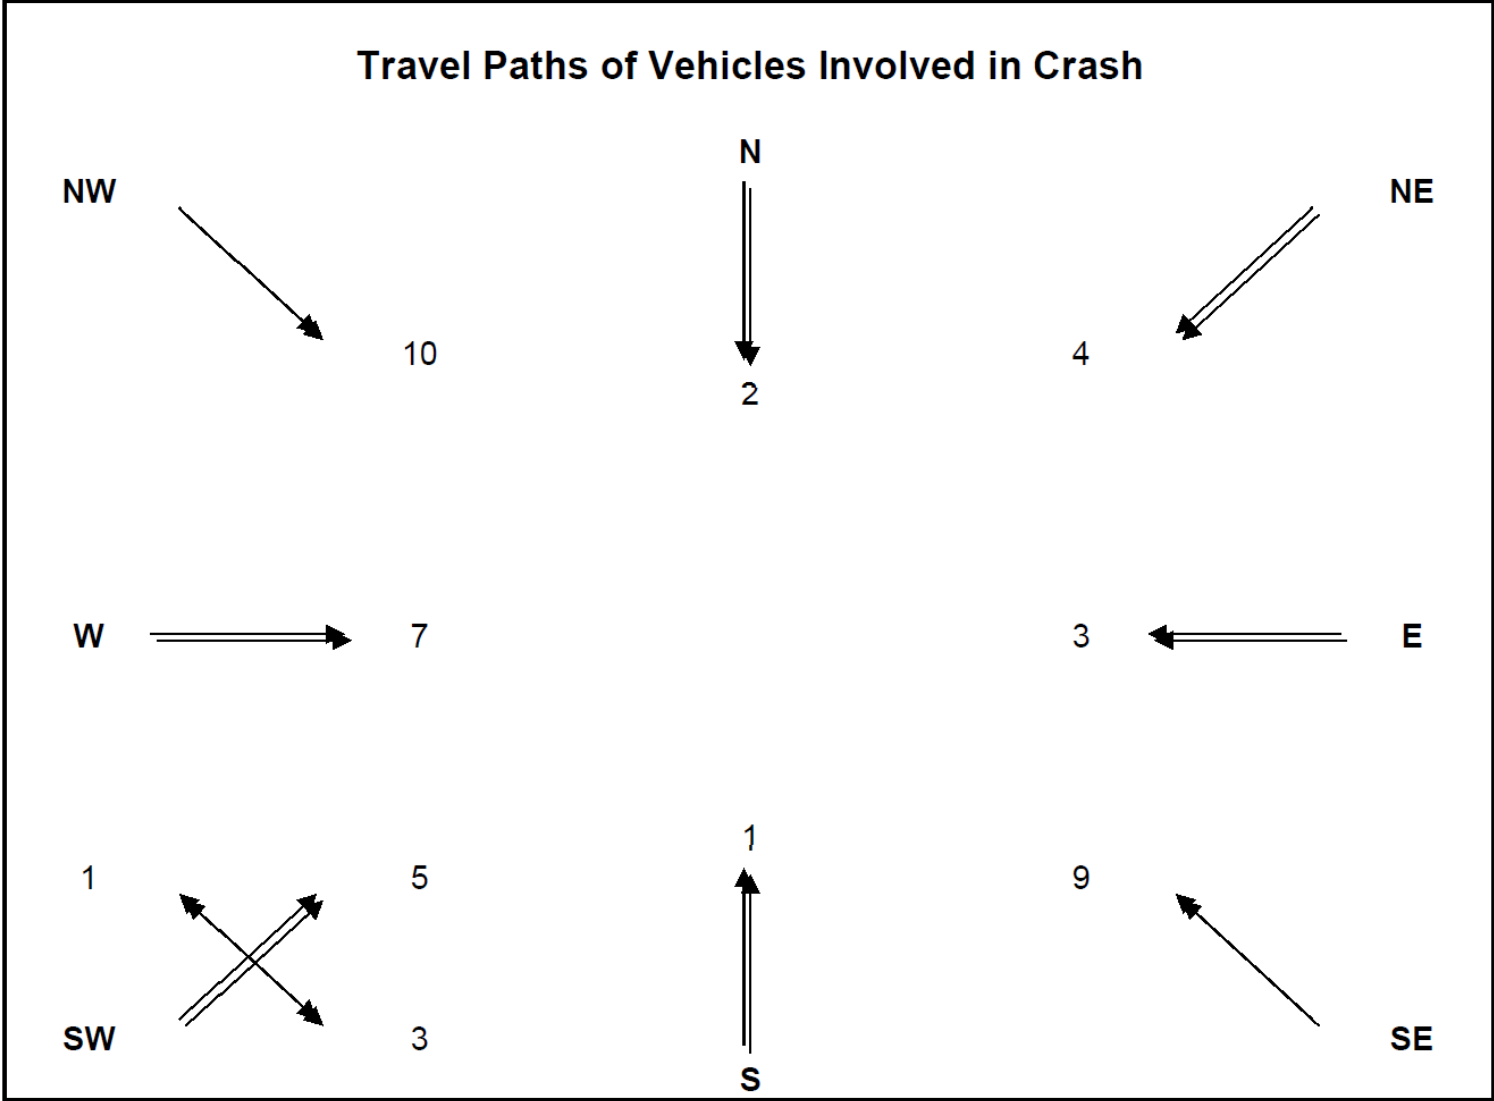
Collision Diagram

Note: This figure shows the travel paths of vehicles 1 and 2 involved in crashes. Unless all crashes are single vehicle, the sum of these counts will not match the total number of crashes. For example, a rear-end crash in the eastbound direction would show a count of "2" vehicles on that travel path. To see counts of actual collisions between movements, use the "Direction_Cross_Tab" sheet created by the tool or construct a collision diagram.

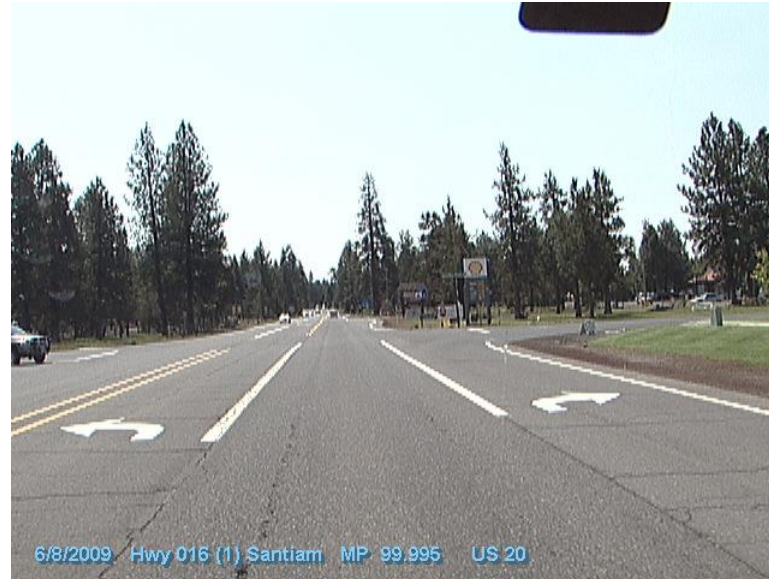
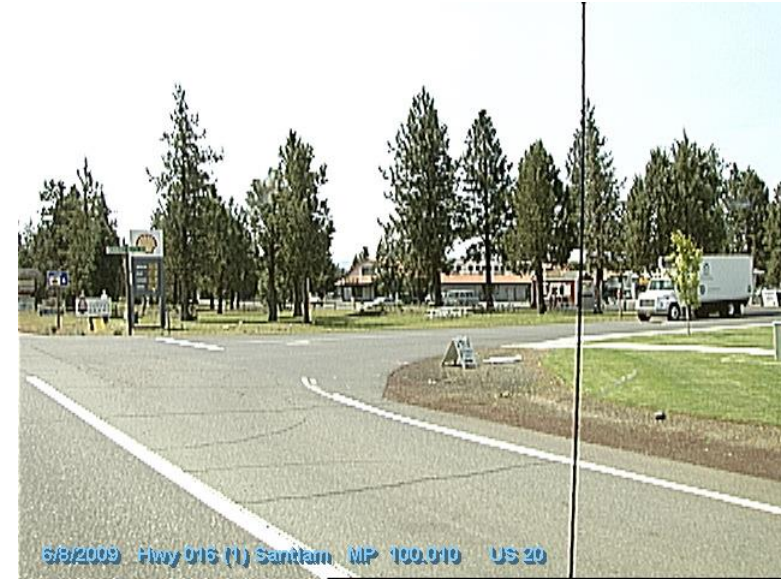
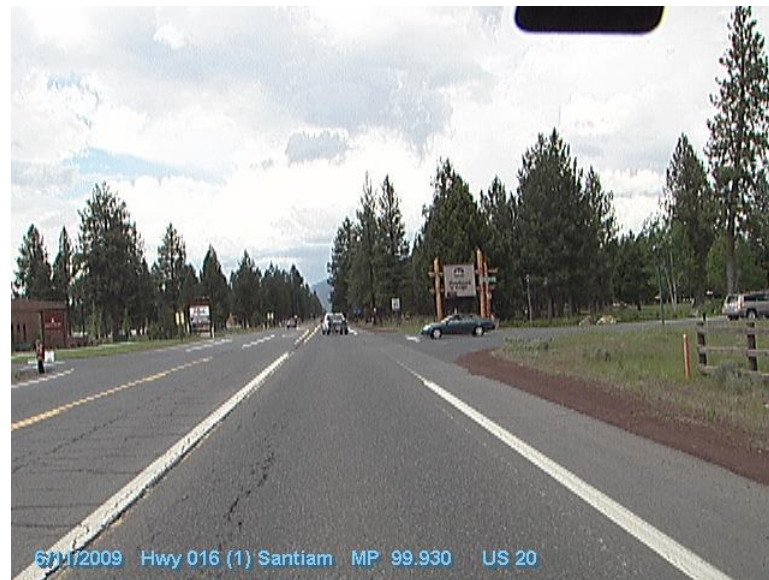
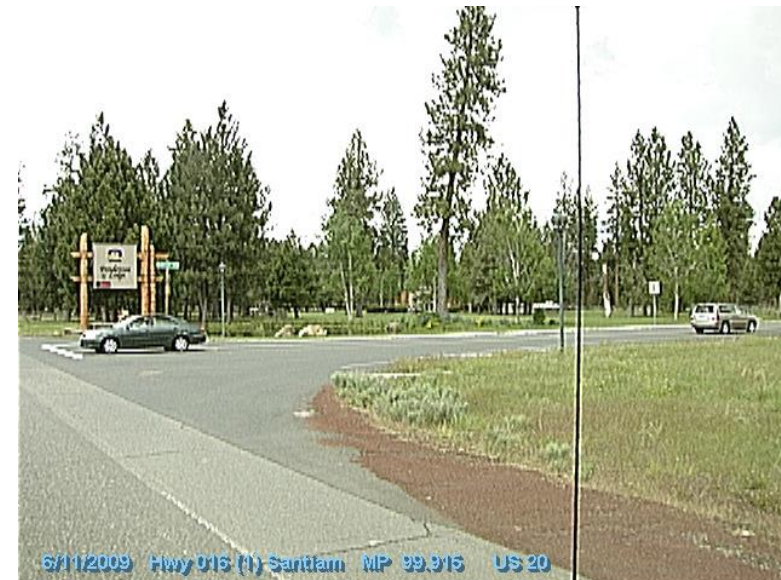
1. Use the Digital Video Log and Google Maps to show conditions before countermeasure was implemented.

- 11 crashes
- 2 severe injury crashes, 5 minor injury crashes
- 4 angle crashes and 4 turning movement crashes
- 8 crashes involved drivers aged 55-64 years
- Leading causes
 - Following too close (3 crashes)
 - Failure to yield right-of-way (3 crashes)
 - Passed stop sign (2 crashes)
