Horsetail Creek Floodplain Restoration: Water Temperature and Fish Monitoring Summary Report

Executive Summary

1. Introduction

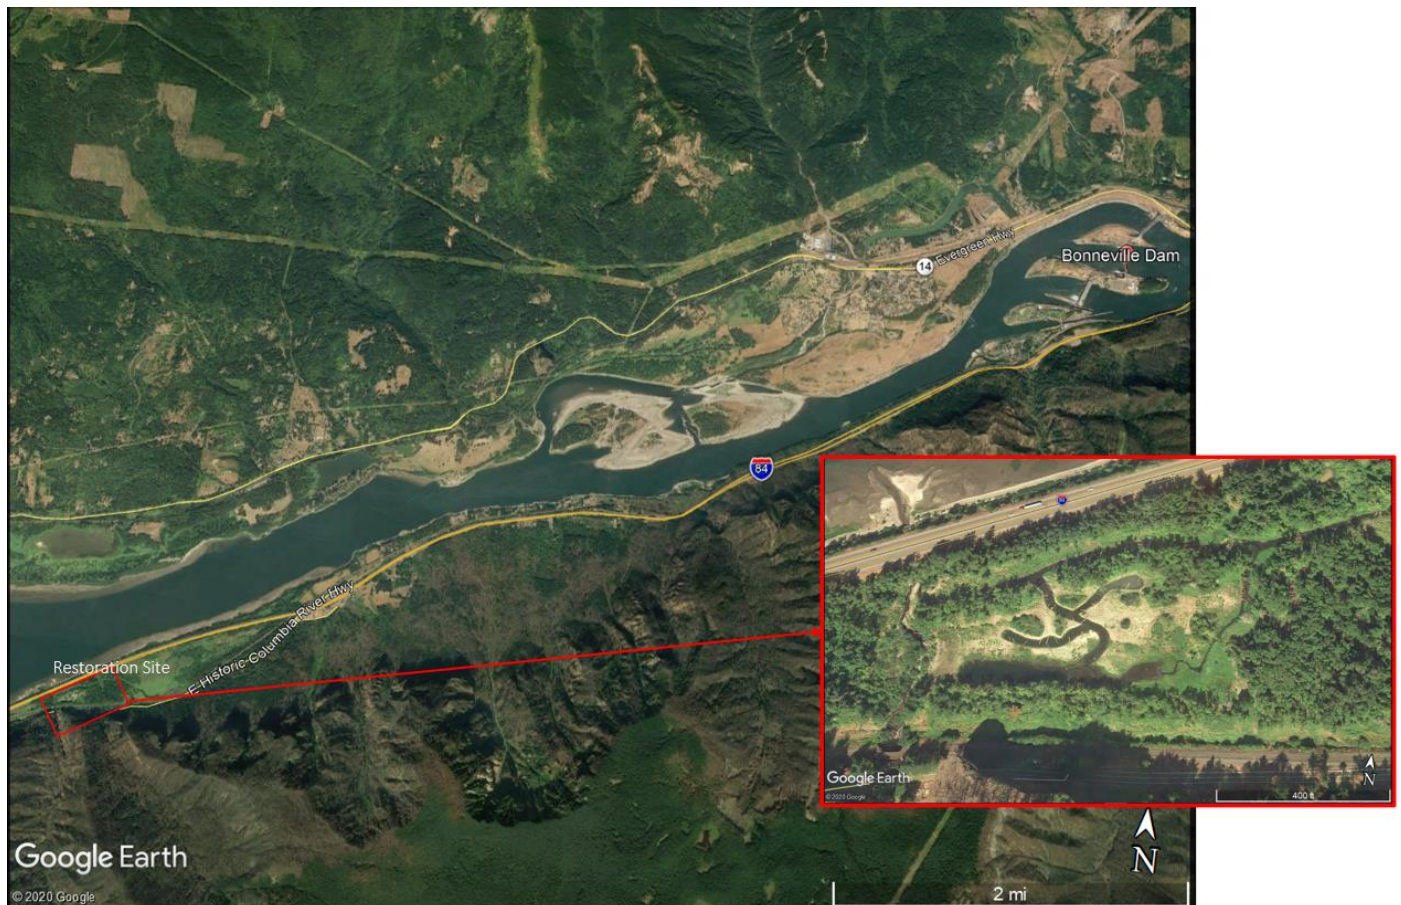
Figure 1: Location of Horsetail Creek Floodplain restoration site.

In 2013, the Lower Columbia Estuary Partnership completed the Horsetail Creek Floodplain Restoration project within the Horsetail Creek floodplain of the Columbia River in Oregon. The 180-acre site is located eight miles downstream of Bonneville Dam in Multnomah County, and 35 miles east of Portland in the Columbia River Gorge National Scenic Area (Figure 1). The project actively restored 36 acres of riparian wetlands and 1.1 miles of salmon-bearing stream, and improved fish passage to 96 acres of floodplain habitat. The project was aimed at restoring ecological function to a site that has been heavily modified by human use over many decades. Specific objectives included, among others, improving fish access by modifying passage through a highway culvert; and improving water quality for salmonids through actions that would help to reduce summer water temperatures within the site, including revegetation and re-routing of flows that had been adversely affecting temperatures.

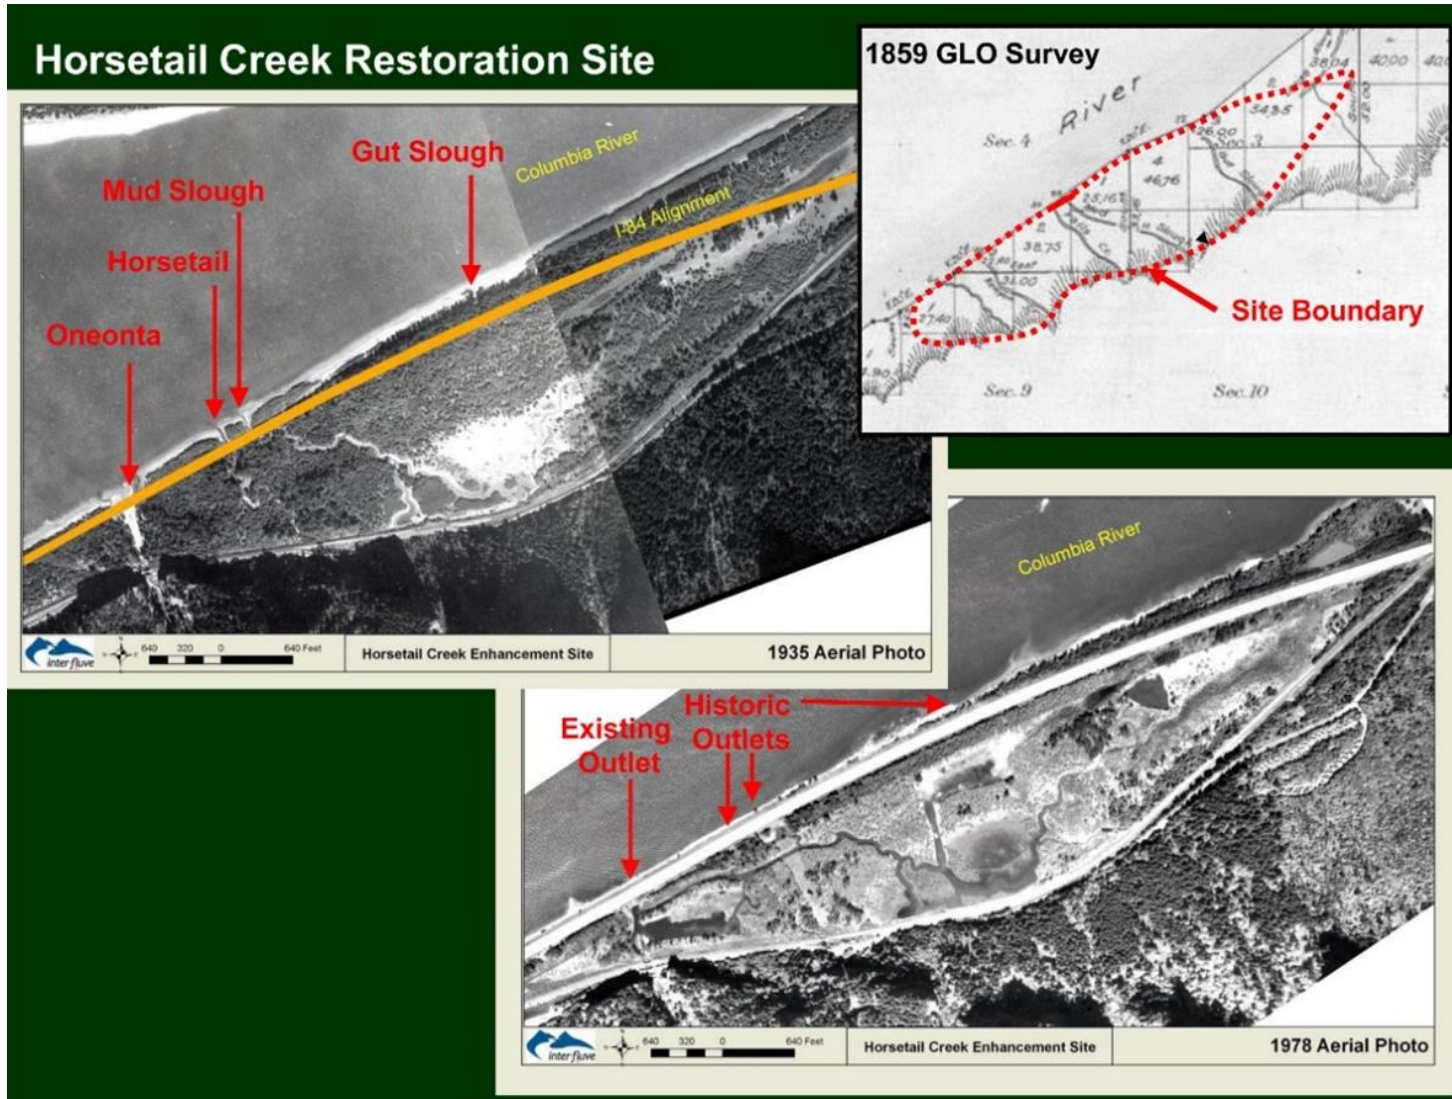
Figure 2: Historical images and maps illustrating trajectory of site hydrology at the Horsetail Creek Floodplain restoration site.

Aerial imagery and 19th century Government Land Office survey maps indicate that the Horsetail Creek floodplain was historically a dynamic portion of the Columbia River floodplain. A network of six separate sloughs and streams conveyed flow coming off the steep hillslope to the south through heavily forested floodplain and into the Columbia River (Figure 2). Throughout the last century, morphology of the site was significantly impacted by the construction of the railroad (1882, across the southern margin), Historic Highway (1912–1914, also across the southern margin), and Interstate 84 (1950s–1960s, across the northern margin) resulting in the placement of new fill, ditches, culverts, and bridges, which have severely impacted the site’s hydrology. During construction of I-84, the Oregon Department of Transportation excavated a large gravel borrow pit to source material for road fill and re-routed the six former sloughs through the floodplain so that all flow coming off the hillslope was conveyed into Oneonta Creek, which was then routed through a single highway underpass culvert to the Columbia River (Figure 3). In addition, the proximity of the borrow pit and porosity of alluvial fan material resulted in a portion of Oneonta Creek flow upstream of the slough confluence to be diverted through the borrow pit (Figure 3, dashed line). Imagery from 1935 shows that the site remained heavily forested at this time, with some clearing at the east end. In subsequent decades most of the vegetation at the site was cleared to facilitate agricultural activity. By 1995, agriculture had ceased and much of the site had re-colonized with overstory vegetation (Horsetail Creek Baseline Assessment, 2010), however significant cleared areas remain.

Figure 3: Historical image sequence with flow paths overlain to illustrate how flow was re-routed through the Horsetail Creek Floodplain restoration site during construction of Interstate 84 in the 1950s and 1960s. Six connections to the Columbia River were reduced to a single connection. Note: the 6th connection at the far east end of the site is not shown here but is visible on the 1859 GLO survey map in Figure 2.

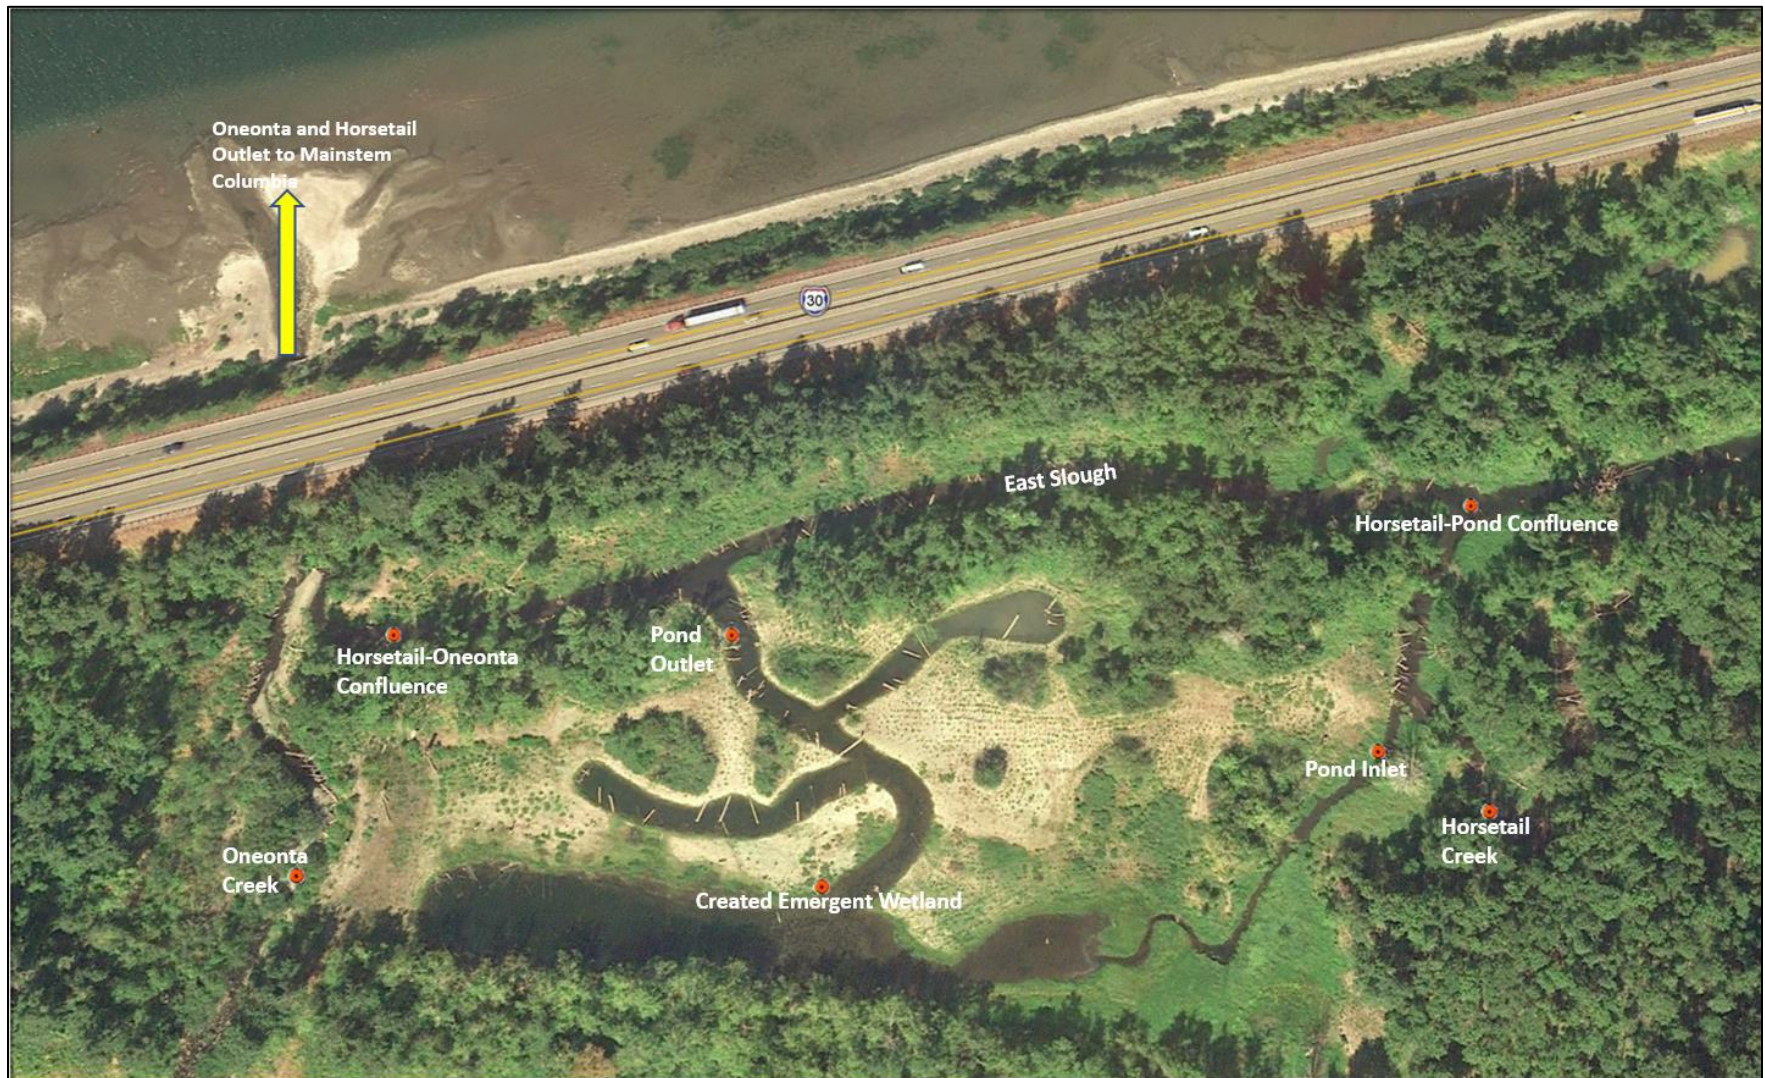
Figure 5: Temperature monitoring locations at Horsetail Creek Floodplain restoration site. Monitoring locations are represented by red dots. The outlet of the I-84 culvert which was retrofitted during construction is shown as the yellow arrow.

We collected hourly water temperature data by deploying Hobo dataloggers at seven monitoring stations (Figure 5) at the Horsetail Creek restoration site from 2010 and 2014-2016 and again between 2018 and 2019. Loggers were placed at stream junctions to evaluate the temperature influence of various flow inputs, at the beginning and ends of stream reaches to evaluate heating through these sections, and in the gravel pond/wetland complex. No temperature data was collected in 2017 as the site was inaccessible due to high water levels throughout most of the summer of that year. 7-day average daily maximum (7-DADM) temperatures were calculated for each monitoring station between June to September or over the available time-period. These were summarized as yearly maximum and average 7-DADM temperatures.

We collected hourly water temperature data by deploying Hobo dataloggers at seven monitoring stations (Figure 5) at the Horsetail Creek restoration site. Data was collected in 2010 prior to restoration, and again from 2014-2016 and 2018–2019 post restoration. Loggers were placed at stream junctions to evaluate the temperature influence of different inputs, at the beginning and ends of stream reaches to evaluate heating through these sections, and in the gravel pond/wetland complex. Time periods for which data were collected are shown in Table 2. No temperature data was collected in 2017 due to high water levels throughout that summer that made the site inaccessible.

Figure 9–12 display time series of pre and post restoration water temperatures at the monitoring locations shown in Figure 5. The data show that Oneonta Creek was consistently warmer than Horsetail Creek throughout the project study timeline (Figure 9). This may be attributed to upstream characteristics of these watersheds that influence the temperature of each stream however we did not include these assessments as part of this study. The Horsetail-Oneonta Confluence was warmer than the Horsetail- Pond Confluence (location where the East Slough joins Horsetail Creek) (Figure 10). It should be noted that data from the Pond Outlet station and the Horsetail-Oneonta Confluence station are only available only through 2016, hence, the complete temperature profiles cannot be displayed. 7-DADM temperatures are higher at the Pond Outlet station compared to the Pond Inlet station (Figure 11), which suggests that the emergent wetland may be heating the water at it flows through. However, it should be noted that temperature in the created emergent wetland (Figure 12) itself was observed to be lower than temperatures at Pond Inlet and Pond Outlet stations.

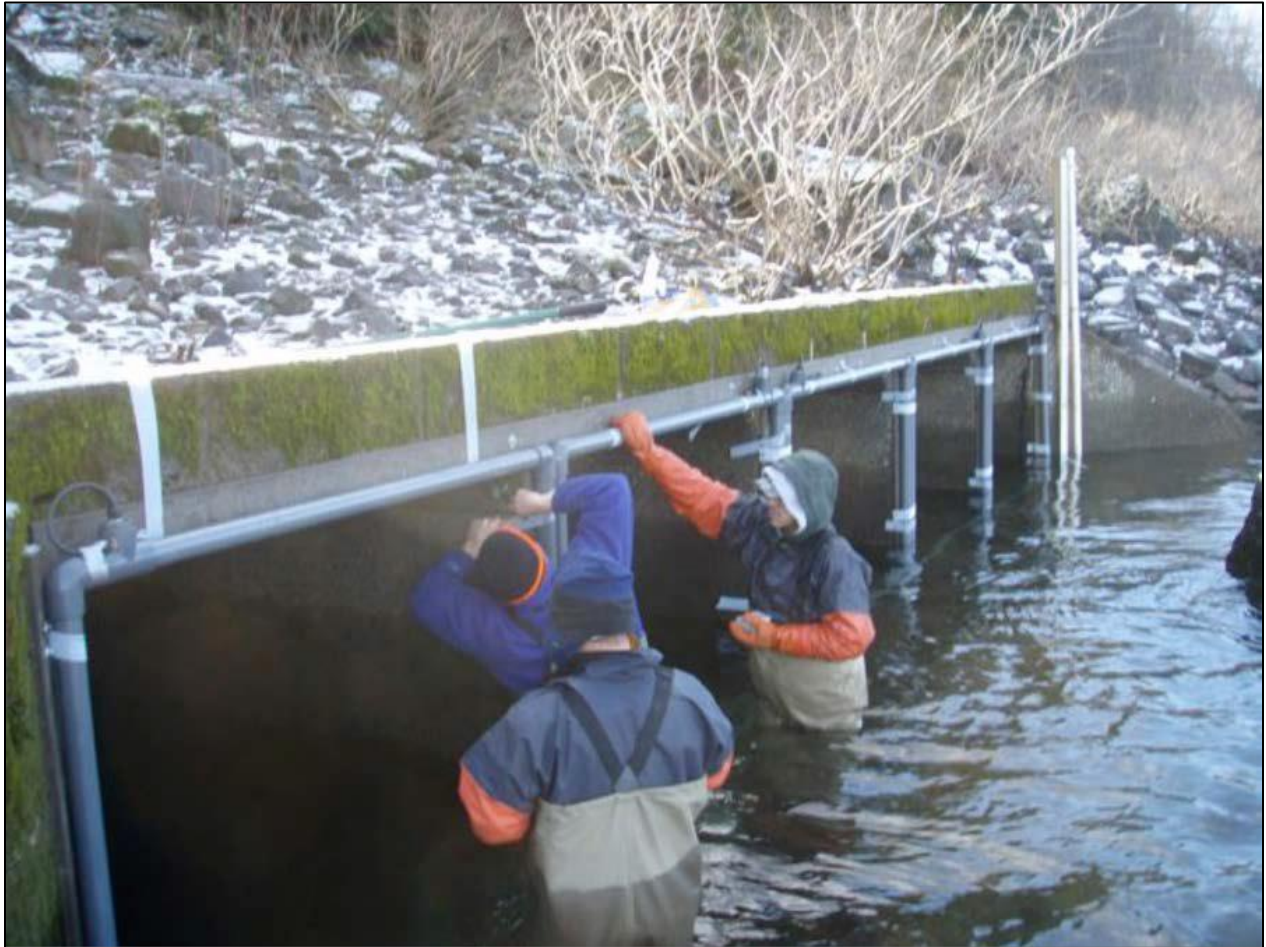
Figure 8: Downstream side of PIT tag array at Horsetail/Oneonta creeks outlet culvert.

The PIT detection array at Horsetail Creek was installed in 2013 following the restoration actions in Horsetail Creek. The array is situated on the upstream and downstream sides of a culvert passing underneath I-84 which connects the confluence of Horsetail and Oneonta creeks with the Columbia River. The array consisted of 10 antennas, five on each side of the 5-barrel culvert (Figure 8). Each year the array was operational from late March or April to October or November. During winter, there was not enough daylight on the southern side of the Columbia River Gorge to provide ample solar power, so operations were intermittent. Due to the dynamic and extreme flows that can occur in the area, individual antennas often sustained damage and had to be repaired or replaced. Often repairs could not be done immediately because high water precluded access. Yet, each year we had antenna coverage on each side of the culvert (Table 3).

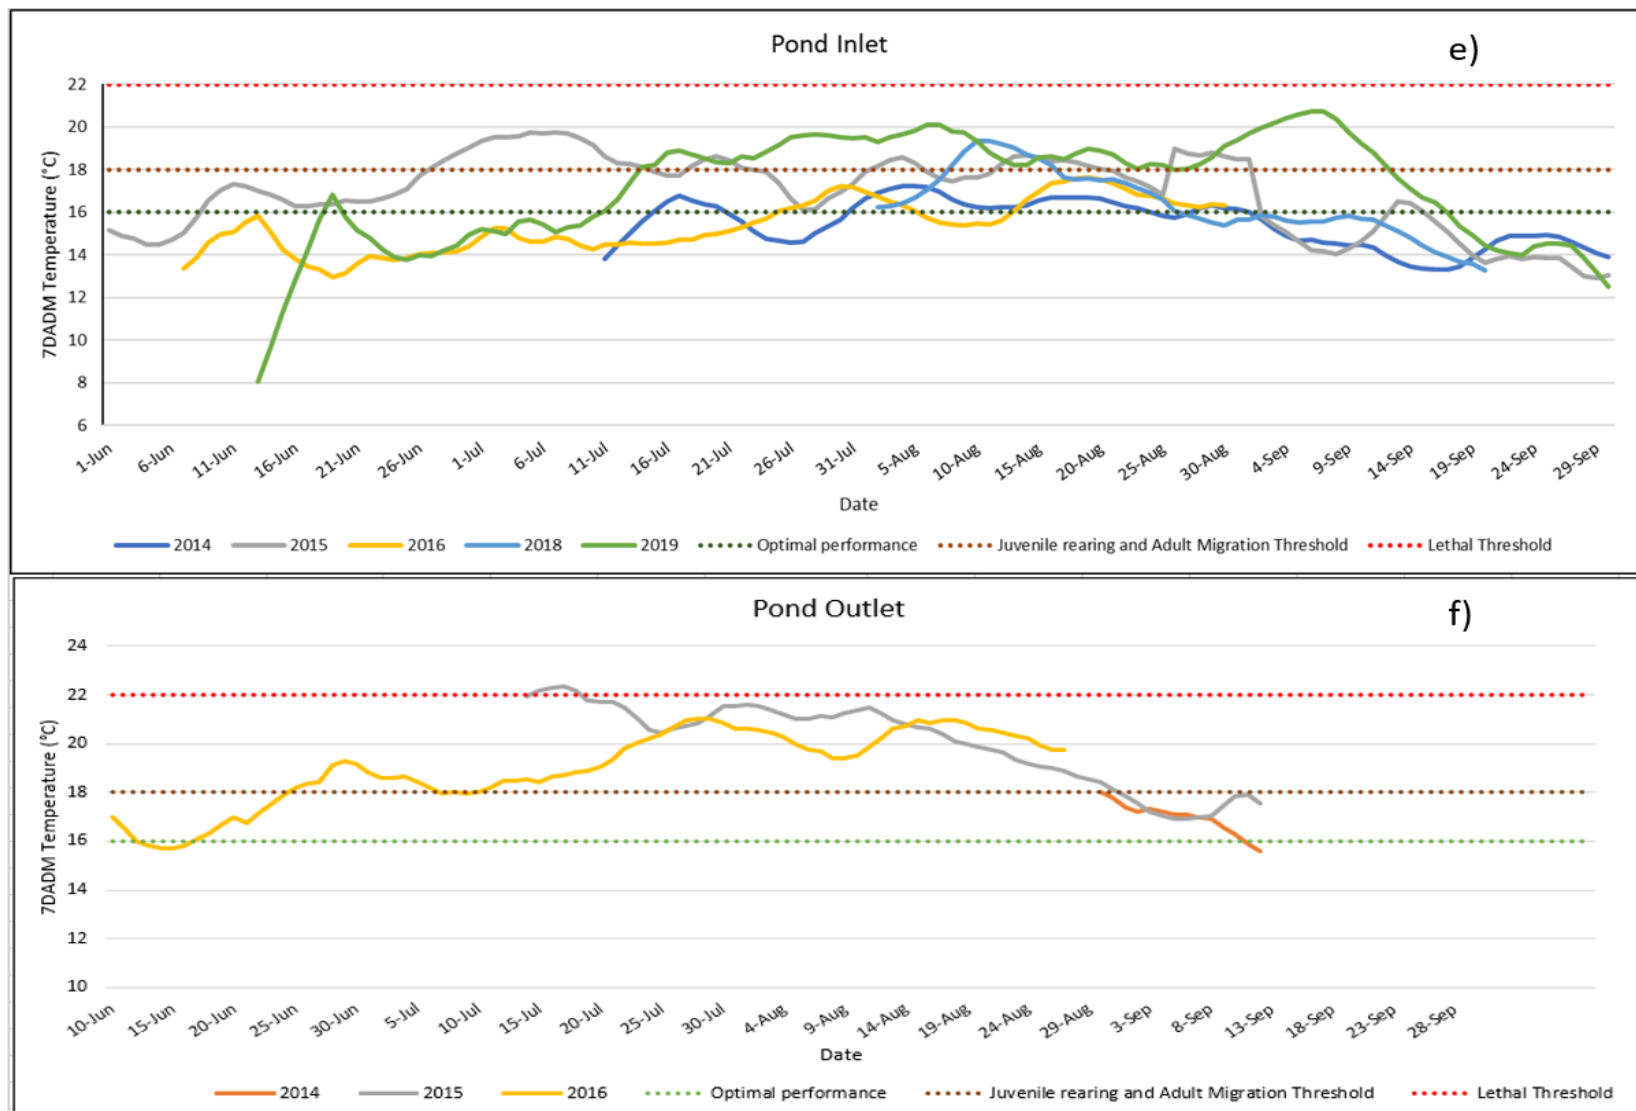
Figure 11: 7-DADM temperatures of e) Pond Inlet and f) Pond Outlet.

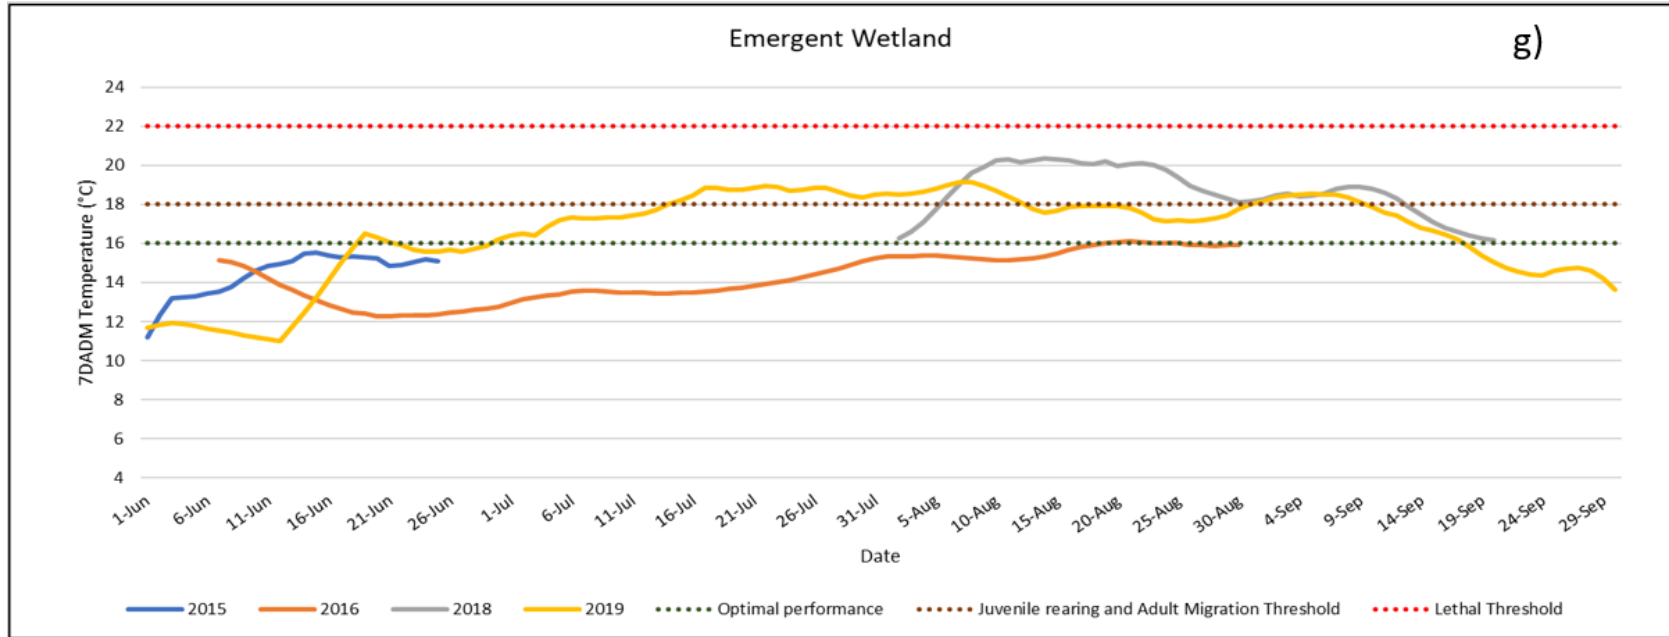
Figure 12: 7-DADM Temperature of Emergent Wetland for summers of 2015 to 2019

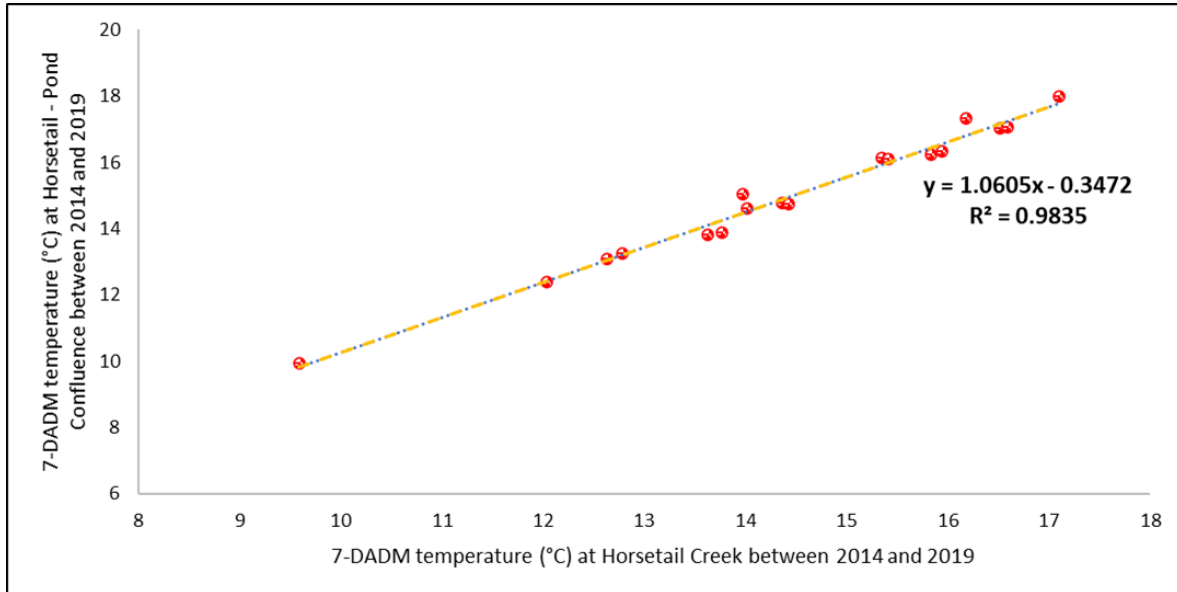
Figure 13: Relationship between monthly average 7-DADM temperatures of Horsetail Creek and Horsetail-Pond Confluence for the post-restoration monitoring period 2014–2019.

A series of regressions were performed to partially assess the relative influences of Horsetail and Oneonta creeks' source temperatures on the overall site temperatures, as an attempt to help evaluate the effect of restoration actions, particularly the re-alignment of Oneonta Creek to its historical condition and resulting flows within the emergent wetland. When 7-DADM temperatures from 2014–2019 at Horsetail and Oneonta creeks were compared to the 7-DADM temperature at the Horsetail-Pond confluence a significant, positive linear relationship was observed (Figure 14, $R^2= 0.98$, $p<0.000$). The 7-DADM temperature at the emergent wetland (2016–2019) also had a significant, positive linear relationship with Horsetail Creek for years 2016–2019 (Figure 15, $R^2= 0.91$, $p=0.004$).

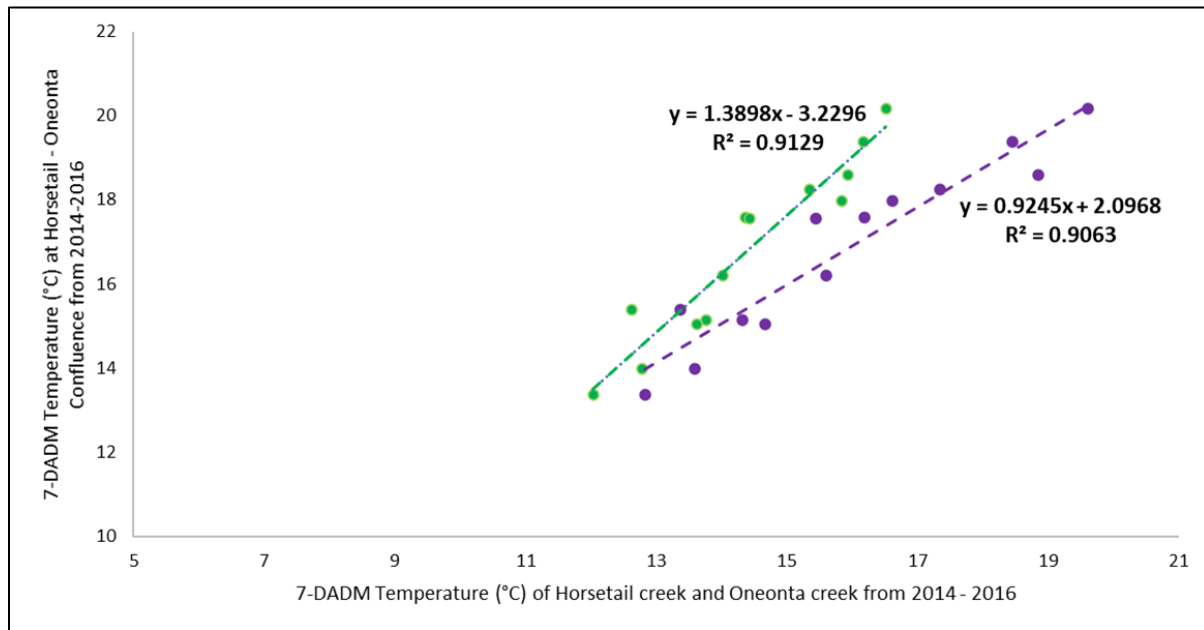
Figure 15: Temperature (°C) relationships between Horsetail Creek (in green) and Oneonta Creek (in Purple), respectively, and the Horsetail-Oneonta Confluence for post monitoring years 2014–2016.

7-DADM temperatures at Horsetail Creek and Oneonta Creek were compared separately to temperature at the Horsetail–Oneonta Confluence location from 2014–2016. Results are shown in Figure 16 and show a strong relationship for each of the creeks (Horsetail: $R^2= 0.91$, $p = 0.001$; Oneonta: $R^2= 0.9$, $p=0.000$). Because Oneonta Creek merges with the Horsetail Creek/East Slough downstream of the Horsetail-Oneonta Confluence monitoring station and is separated from it by a large gravel bar, it is unlikely to be influencing water temperature at the station and the observed relationship is likely more coincidental than causal, however.

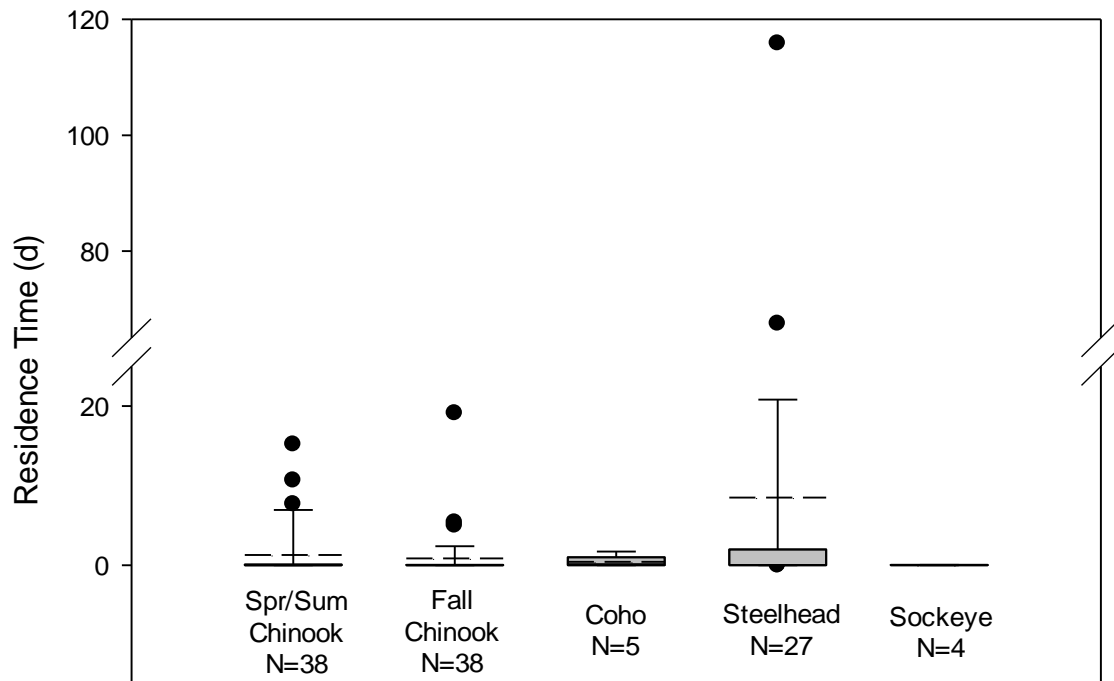
Figure 17: Residence times for juvenile spring/summer Chinook, fall Chinook, coho, steelhead, and sockeye. Box boundaries indicate 25th and 75th percentiles, error bars represent 10th and 90th percentiles, and dots are outliers. The solid line is the median (not always visible), and dashed line is the mean.

Juvenile salmon residence times ranged from a single detection to 115 days (Figure 17). Most salmon were detected for less than one minute. Steelhead had the longest residence time with one individual residing for 115 days. A second steelhead was detected shortly after being barged, resided for 67 days, after which it was detected on the Bonneville ladder, indicating that it had used the Horsetail Creek area to rear until it was ready to return upriver. Spring/summer Chinook and fall run Chinook had similar residency patterns with approximately 75% residing for less than a minute and a few residing for 15–19 days. Juvenile coho and sockeye had the shortest residence times of one day or less for coho and one hour or less for sockeye.
