# Culvert Repair Programmatic Agreement (CRPA) Pilot Final Report

Report Prepared by  
William Warncke and Allen Gillette, ODOT

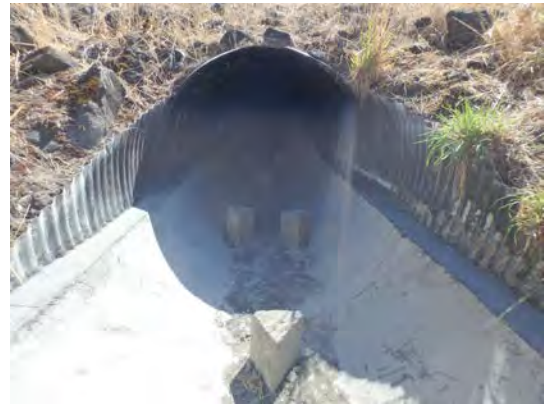
Inside culvert showing invert paving and roughness features (9/20/16)

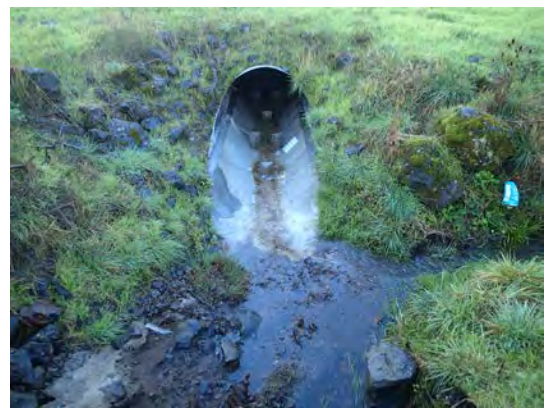
Roughness features creating turbulence, increased water depth, and longer flow path during low flow (10/26/16)

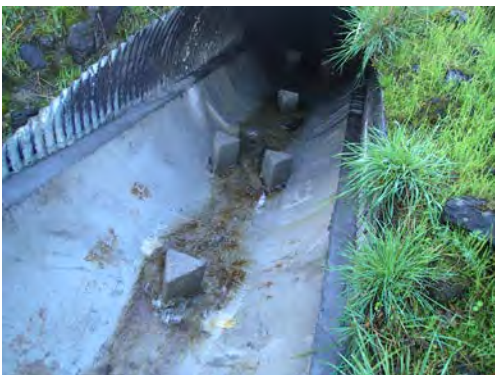
Roughness features creating turbulence, increased water depth, and longer flow path during low flow (10/26/16)

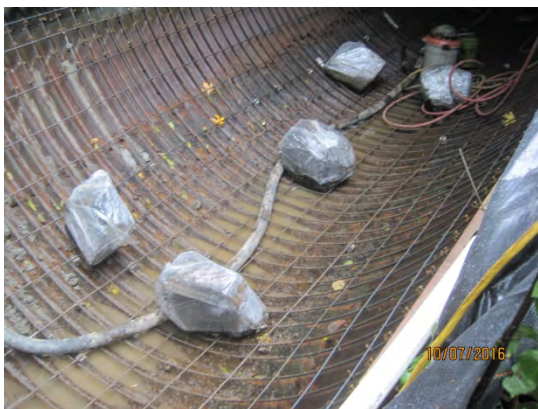
During invert paving - rocks are covered in plastic to keep the concrete off the natural rock surface (10/7/16)

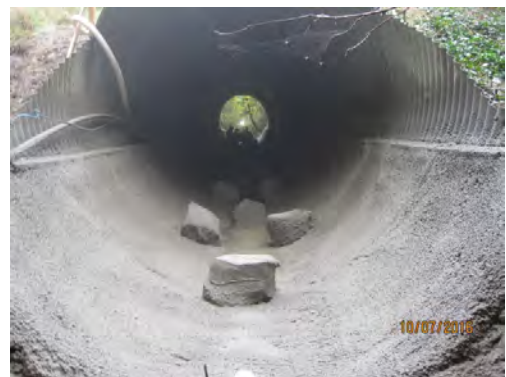
Post-construction bracing and invert paving (10/20/16)

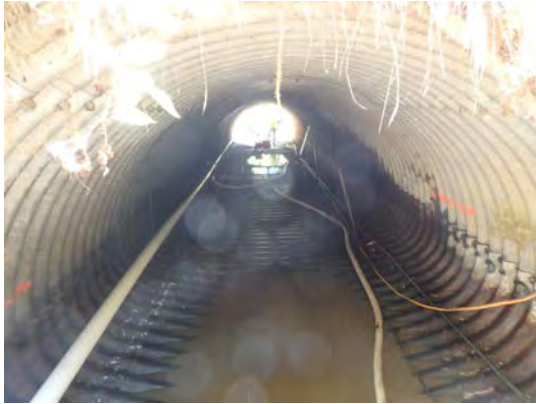
During construction dewatering and cleaning out the culvert (9/20/16)

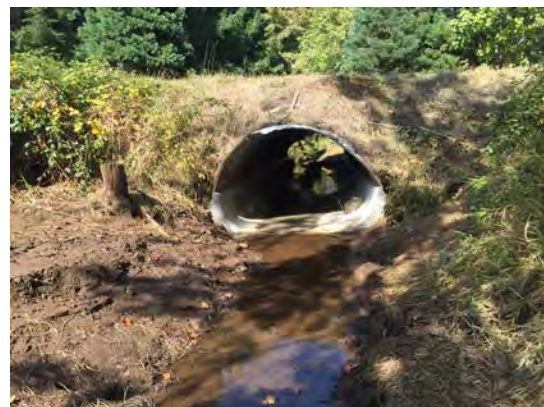
Post-construction looking upstream at the outlet (9/29/16)

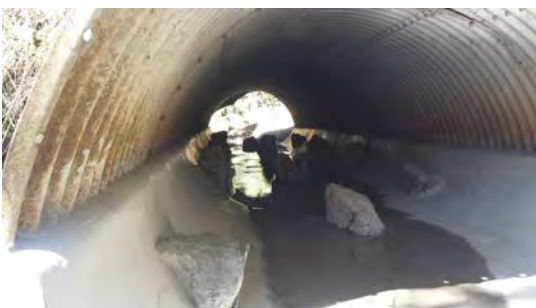
Post-construction - Invert paving and fish rocks installed (9/29/16)

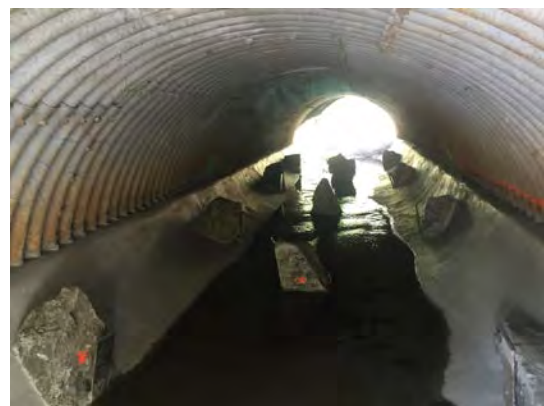
Post-construction - Invert paving and fish rocks installed (9/29/16)

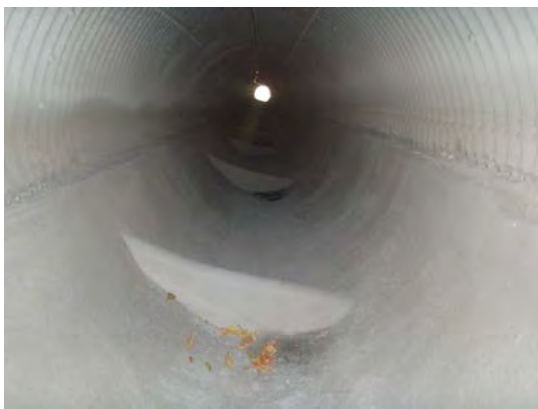
Invert paving with sloped weirs prior to the return of flow (9/20/16)

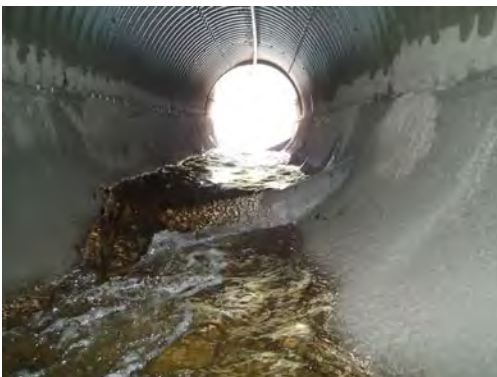
The slump in the middle of the pipe resulted in a less backwater at this weir location (near inlet) than anticipated (10/26/16)

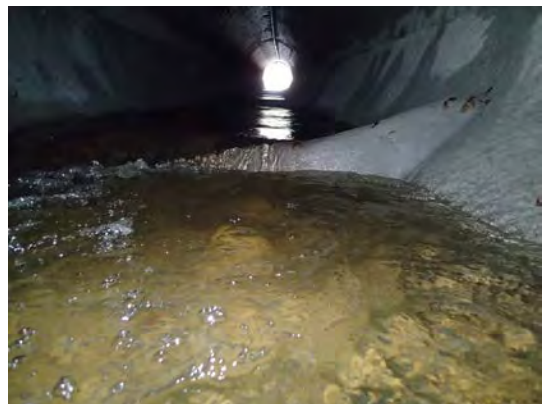
Typical sloped weir configuration with low flow (10/26/16)

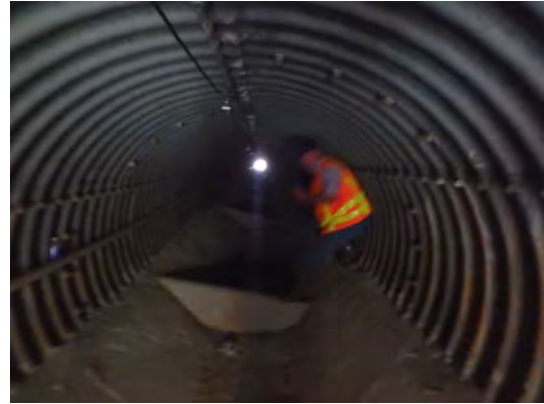
Sloped weirs prior to re-watering of culvert (9/20/16)

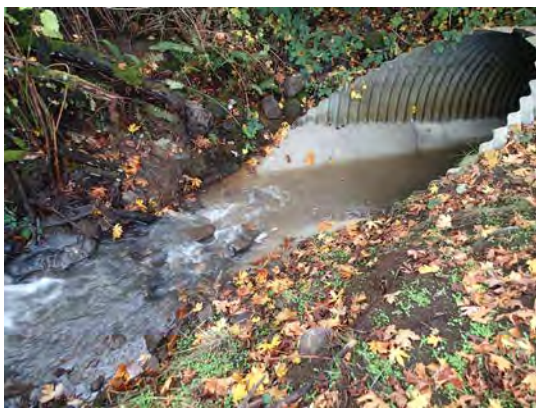
Culvert inlet post-construction (10/26/16)

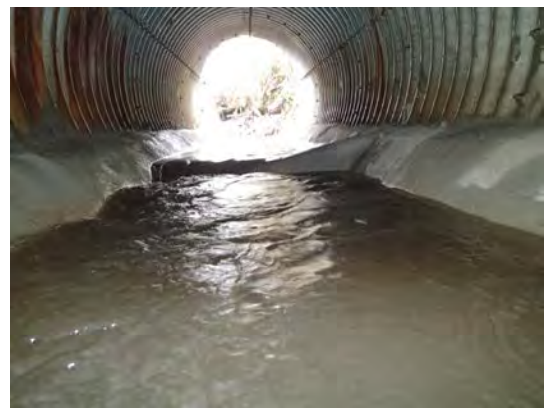
Sloped weir looking upstream toward culvert inlet (10/26/16)

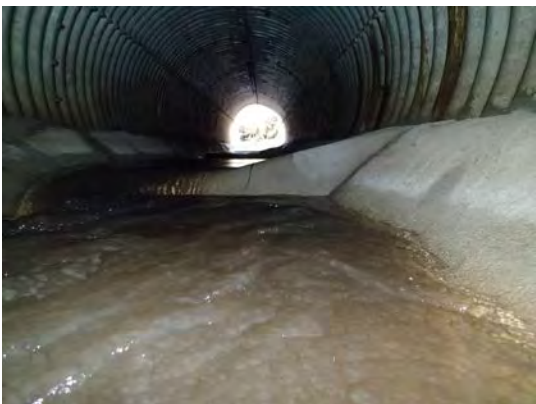
Sloped weir looking upstream toward culvert inlet (10/26/16)

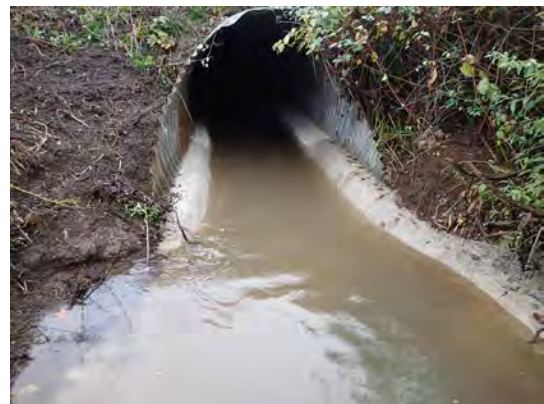
Culvert outlet – backwatered (10/26/16)

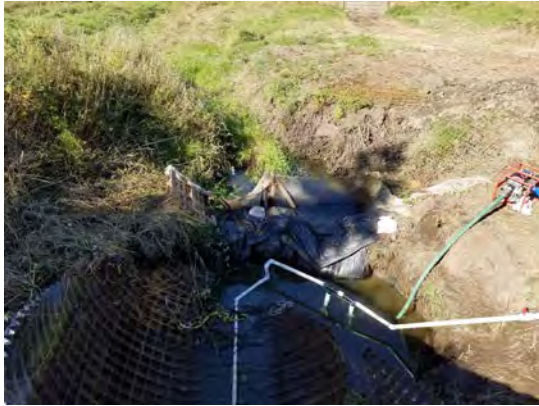
In-water work area isolation at culvert inlet - 2017

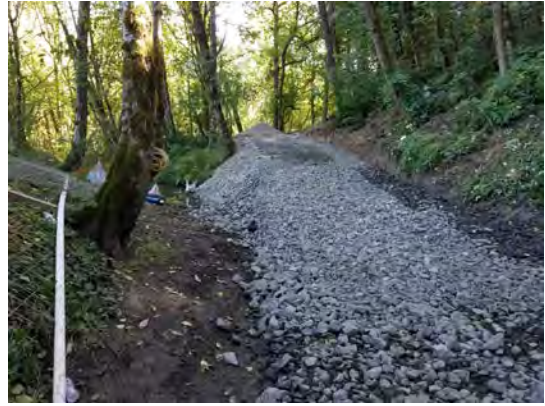
Access road at outlet - 2017. Water is piped around work area in pipe on right of photo

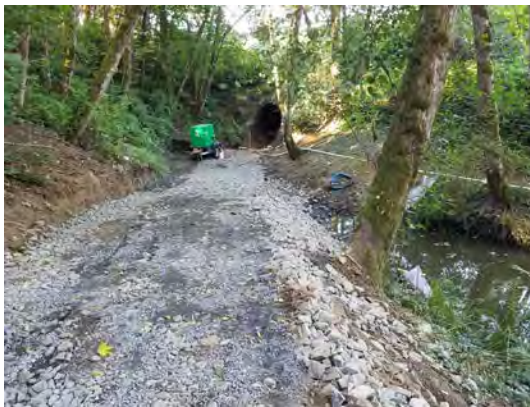
Looking toward culvert outlet and access road - 2017.

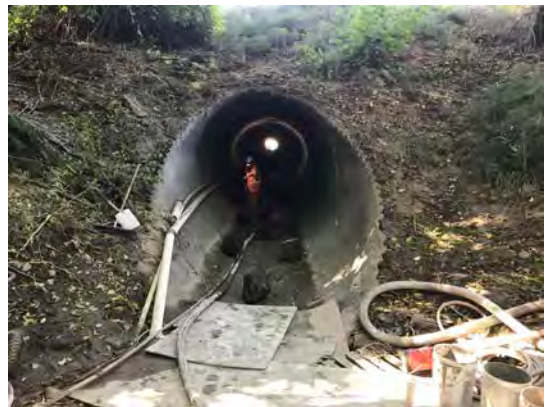
2018 construction - placing fish rocks

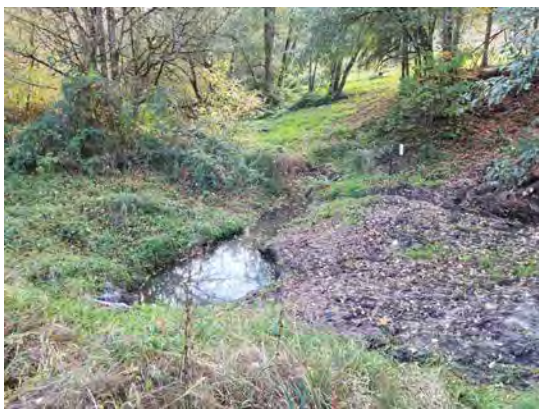
Outlet of culvert is backwatered

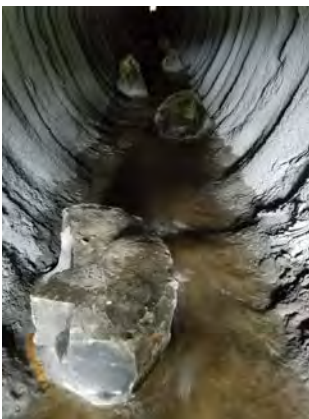
Outlet of culvert during construction showing work area isolation

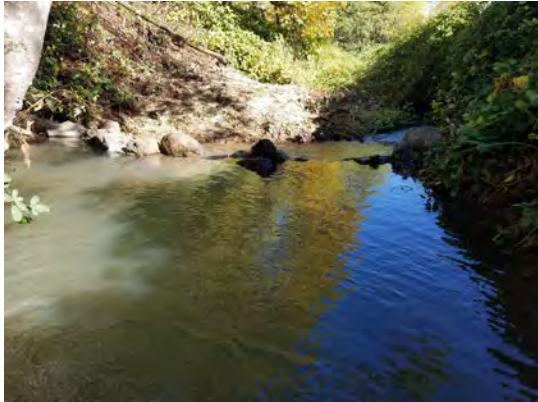
Looking upstream at boulder weir below culvert outlet to back water up into culvert

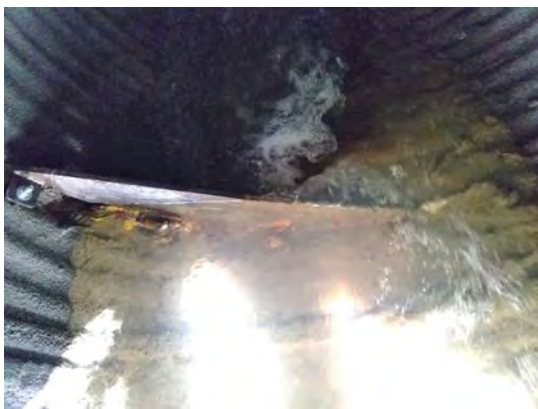
Baffle inside culvert during lower flow – steel corner baffles are bolted to culvert

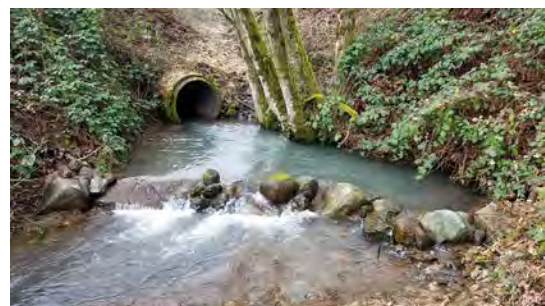
Downstream weir at winter base flow – February 2018

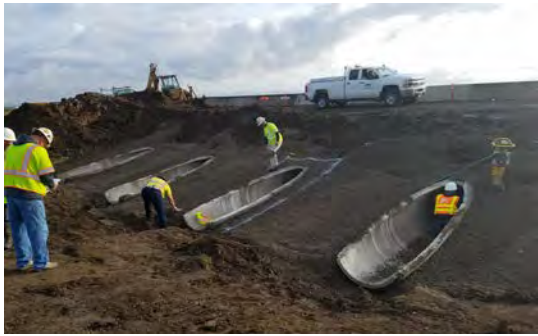
New culvert outlets in construction

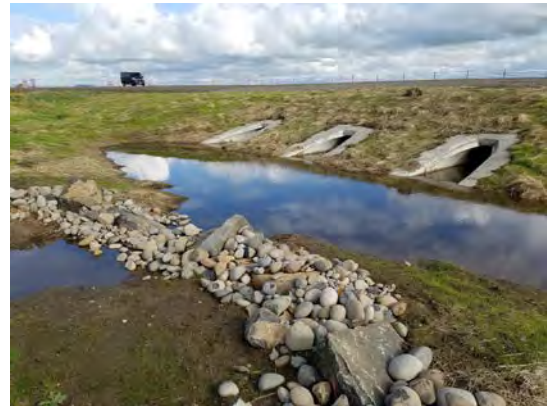
New downstream weir to back water into culverts

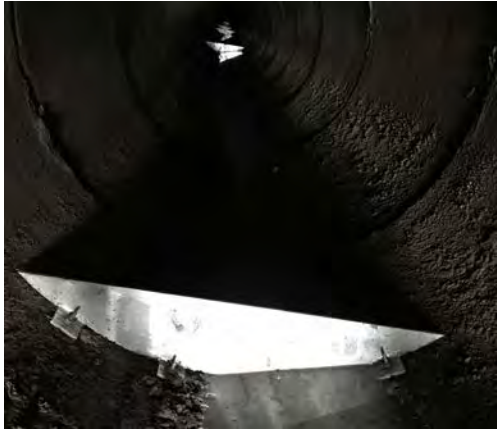
Internal culvert baffles

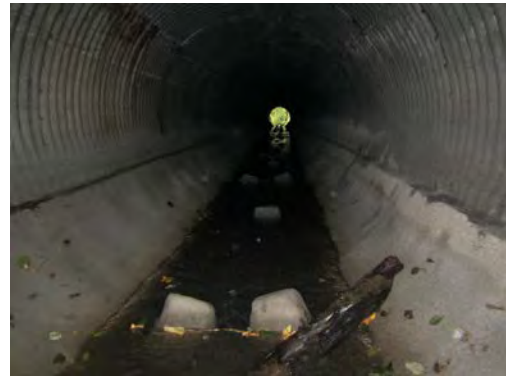
Inside culvert showing invert paving and simulated fish rocks – some debris on double rock installation

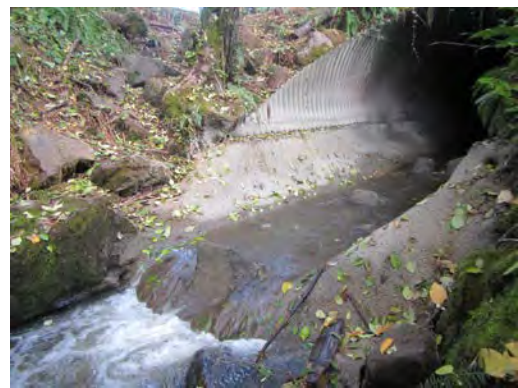
Culvert outlet at winter base flow. There is a steep section at the end of the culvert treatment - 2017

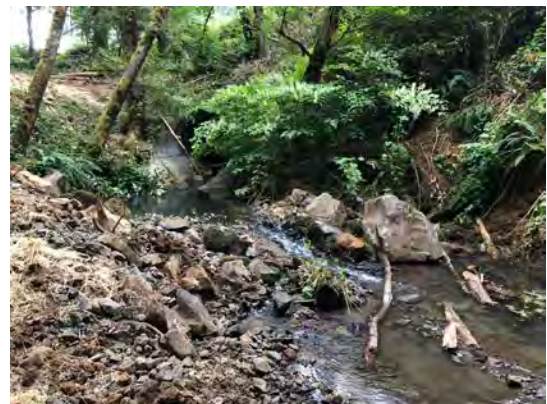
New downstream weir to back water up into culvert. Installed summer 2018

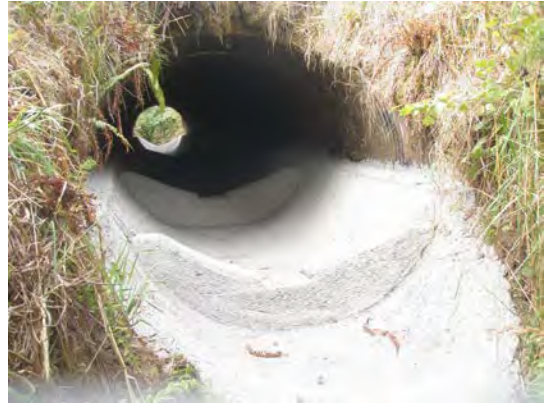
Culvert outlet showing invert paving and weirs

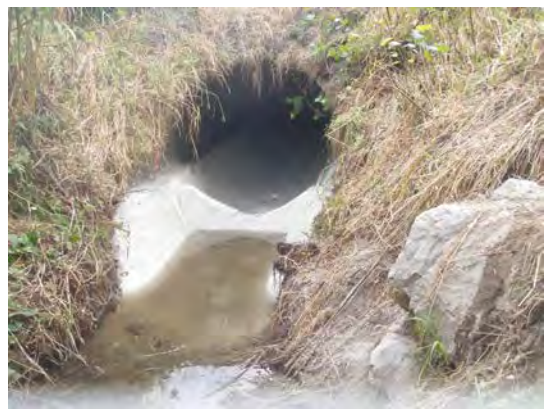
Inlet of culvert flow returning to creek

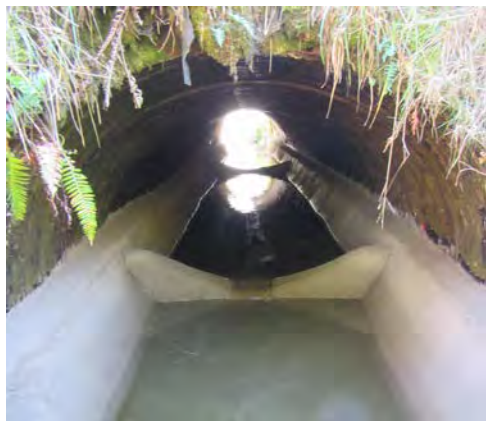
Inside Culvert showing flow returning to creek

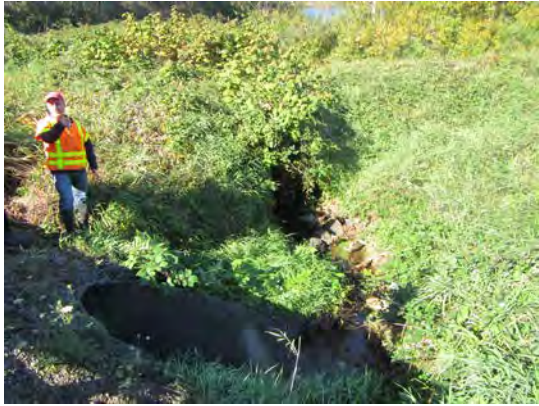
Culvert outlet looking downstream toward boulder weir

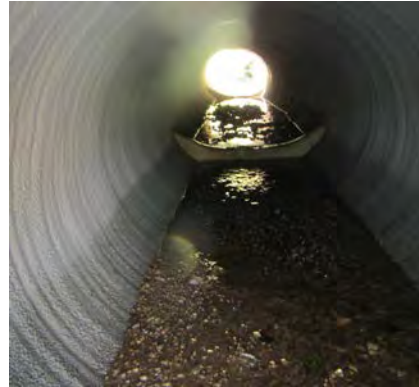
Inside culvert showing some accumulation of substrate near inlet

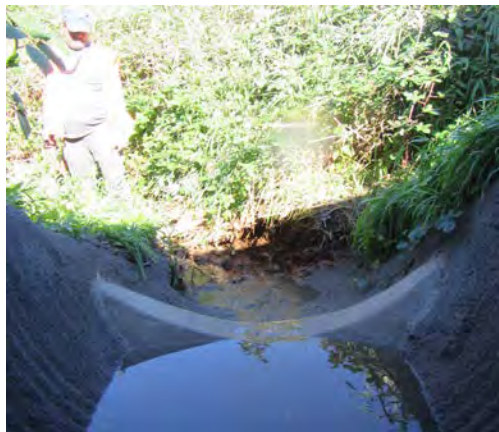
Looking downstream at outlet of culvert
