CHAPTER 5: LOWER WILLAMETTE SUBBASIN TMDL

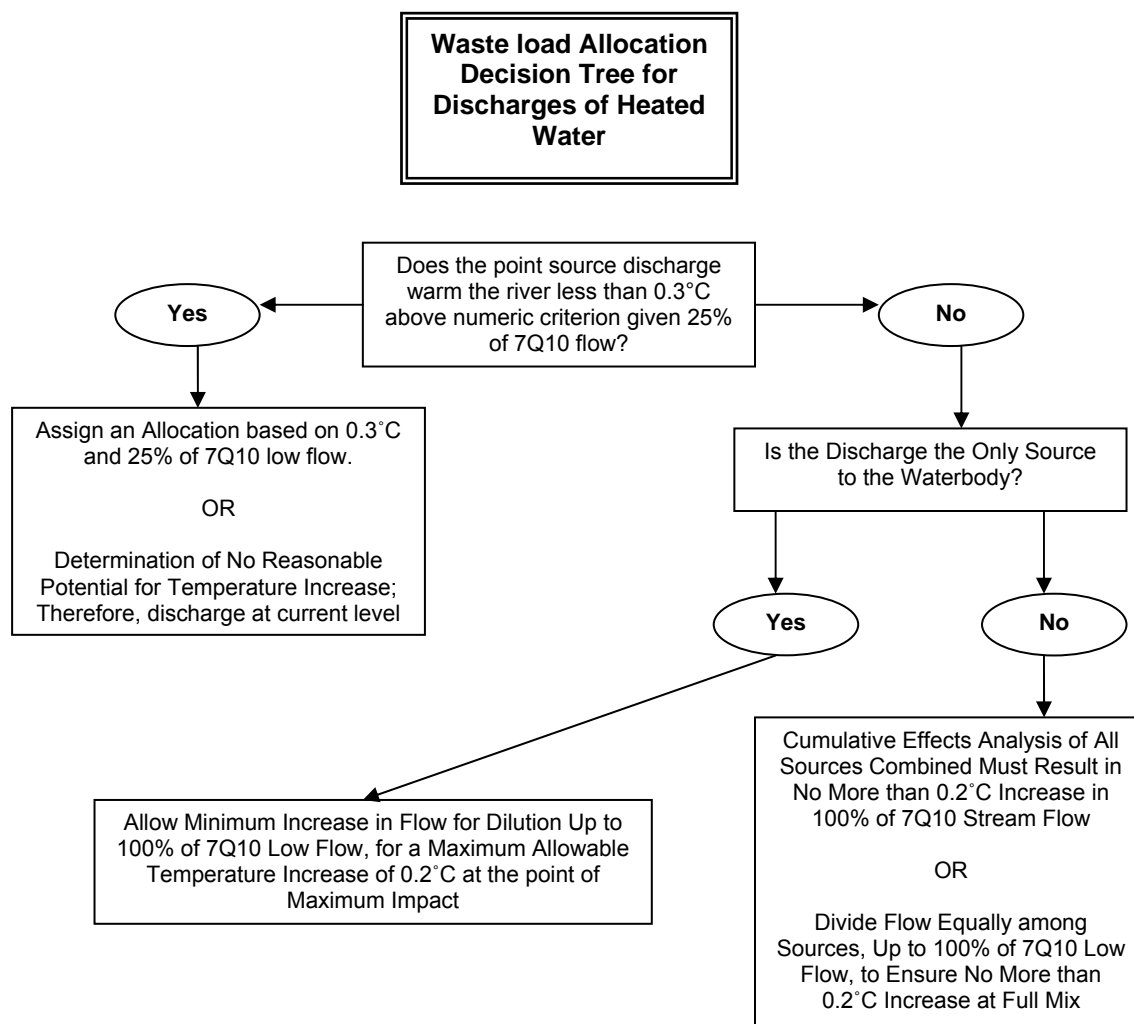
The waste load allocation flow chart on the next page assumes an allowable change in temperature above criteria of 0.3°C within 25% of the 7Q10 low flow (a calculation of the seven-day, consecutive low flow with a ten year return frequency). This is the initial step in the development of a waste load allocation on smaller streams or when information is insufficient to allow a greater proportion of receiving water flow for mixing.

The resultant temperature increase in fully mixed receiving water would be limited to 0.08°C. More than the minimum flow allowance (25% of 7Q10 low flow) may be allocated to an individual source when analysis demonstrates standards attainment. The resulting temperature increase in this scenario depends on the proportion of low flow allocated, but should not exceed the point source sector allocation of 0.2°C over the entire waterbody. Moreover, each discharge is also required to ensure the local effects of discharge will not cause impairment to health of fish by meeting thermal plume requirements adopted under OAR 340-41-0053(2)(d).

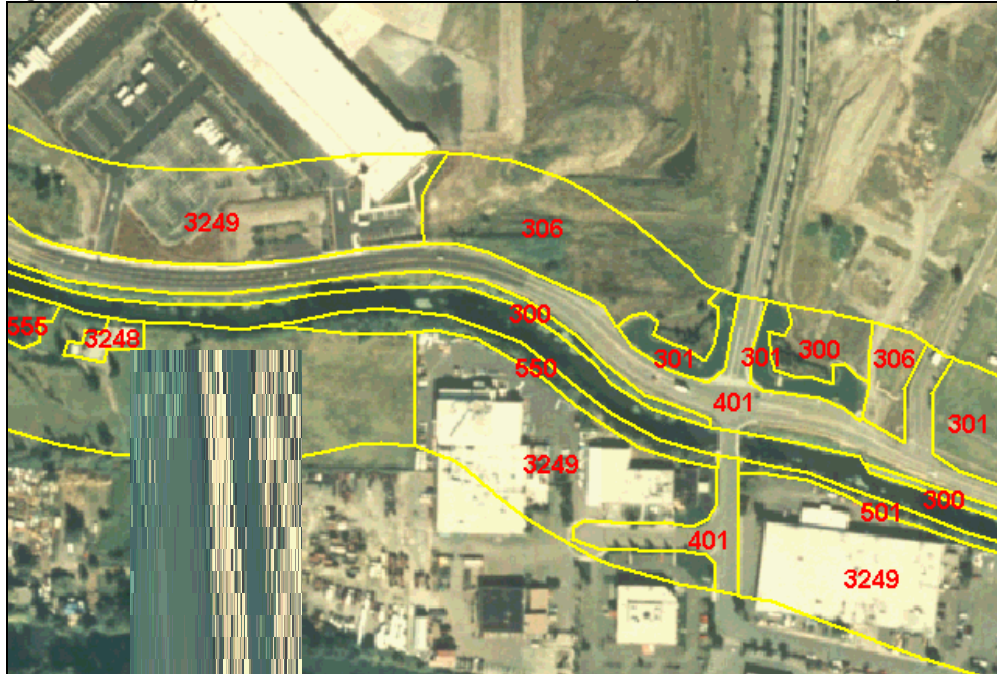
Figure 5.26. Example of Near Stream Land Cover Delineation (See Table 3.8 for a description of the numeric codes)

Every near stream vegetation code was quality checked against aerial photographs by ODEQ. Ground level measurements were collected by ODEQ during the summer of 2001 at 17 locations throughout the watershed for vegetation classification and quantification (Figure 5.27).

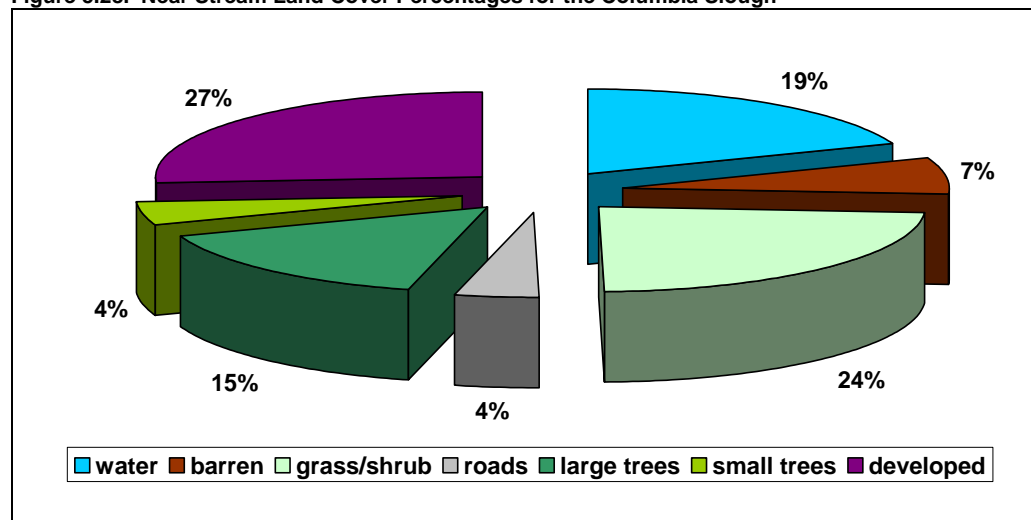
Figure 5.28. Near Stream Land Cover Percentages for the Columbia Slough

ODEQ personnel made field measurements of vegetation height at 17 riparian monitoring locations. Forty-seven large trees, almost exclusively large Cottonwood, were measured at locations where large trees appeared to be the dominant riparian vegetation. The average large tree height was 85 feet (26 meters). Thirty-two small trees were measured at locations where small trees appeared to be the dominant riparian vegetation. The average small conifer tree height was 35 feet (11 meters). Large tree heights varied between 55 and 120 feet.

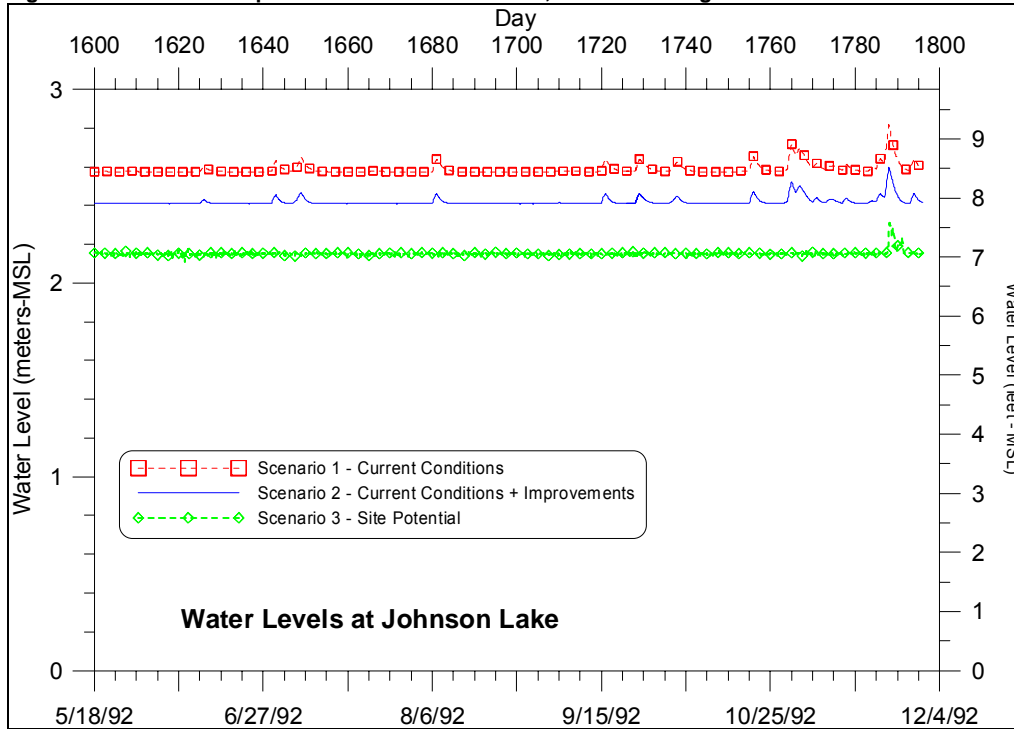
Figure 5.38. Water level predictions at Johnson Lake, Whitaker Slough.

Model predicted water levels of the scenarios for Johnson Lake were plotted in **Figure 5.38**. Johnson Lake is located at the upstream end of Whitaker Slough and the impact of culverts and/or bridge improvements can be seen. For scenario 1 water levels were highest because the culverts were simulated using 1992 conditions. Scenario 2 included past and planned culvert resulting in decreased water levels of about 0.5'. Scenario 3 simulated the complete removal of the culverts and water levels were predicted to be 1.5' lower than for Scenario 1. Lower water levels result in shorter residence times and cooler water temperatures.

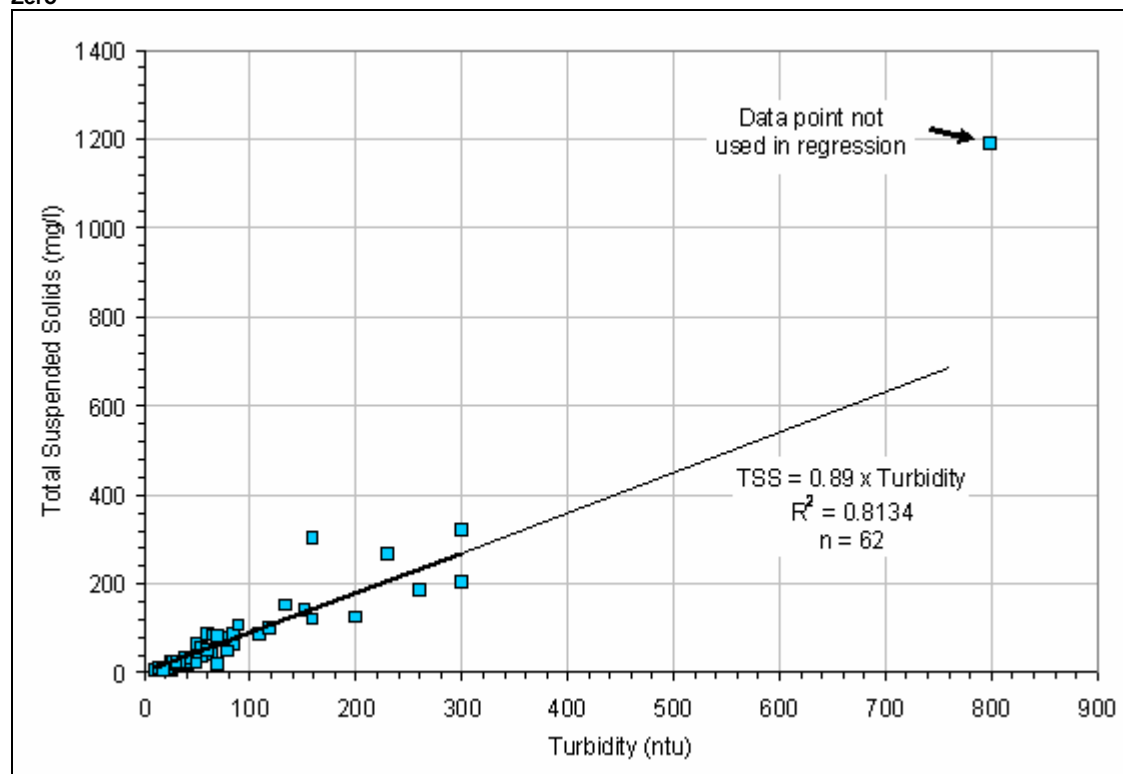
Lastly, **Figure 5.128** depicts the relationship between TSS and turbidity for sixty-two samples collected in Johnson Creek during the 2001-02 sampling period. The relationship appears strong, which suggests that turbidity may also be considered as an instream surrogate measure for DDT. One potential advantage of using turbidity as a surrogate measure is that it can be measured continuously instream using automated equipment. Analysis of continuous turbidity data could help prioritize TMDL implementation efforts by identifying particular times of year, flow conditions, precipitation conditions, etc. that tend to result in standards violations, allowing stakeholders to implement more effective Best Management Practices.
