# Culvert Repair Programmatic Agreement (CRPA) Pilot Final Report

Report Prepared by  
William Warncke and Allen Gillette, ODOT

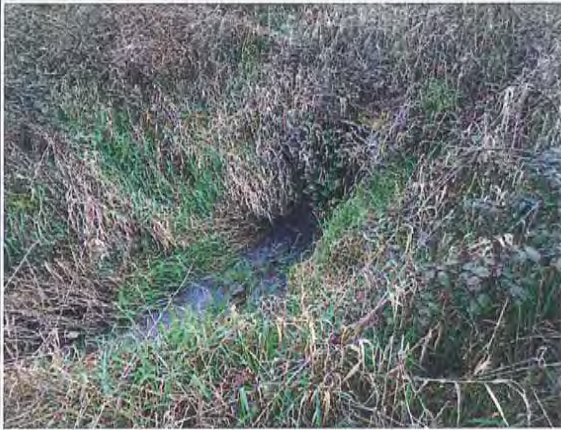
Photo 1: Inlet end (C) -

The Senecal Creek Tributary culvert under I-5 at MP 277.98 is failing. A culvert repair was approved under the CRPA in 2016, but the culvert was found to be too structurally degraded for the proposed fix, which was an invert pave. This initiation form represents an update to the previous approval, which is attached. The changes to the previous proposal include a modifying the proposed fix to a centrifugally cast reinforced concrete liner and minor modifications to the fish rock size and placement.

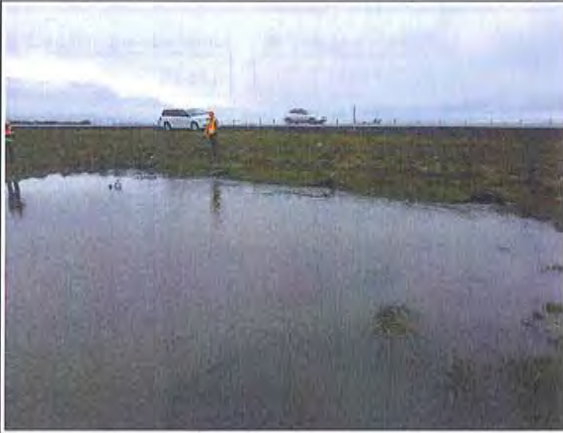
Photo 1: Inlet end (C) -

A set of four culverts that convey a tributary of tLake Creek under I-5 at MP 227.47 are failing and require maintenance. The majority of the length of each of the culverts are made of concrete, but the last 50' on both ends are CMPs. The concrete sections of these pipes are functioning well, but the CMP sections are rusted out. The proposed fix is to remove and replace the 50' CMP sections via an open trench. The proposed fish passage improvement is to construct a boulder weir immediately downstream of one of the four culverts in order to backwater it. Hydraulic analysis shows that one weir will be sufficient to backwater the length of the single culvert and will not create a jump height greater than 6".

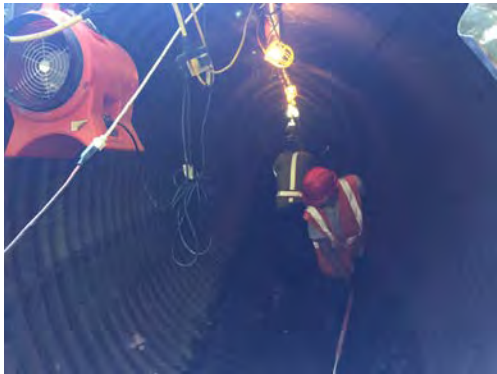
Contractor personnel cleaning stream material out the culvert to prepare for invert paving (8/5/16)
